**Technical Service
Information Bulletin**

INSTRUMENT PANEL RATTLE

'04 – '06 RX 330, '06 RX 400h, & '07 RX 350

NVH
NV002-06

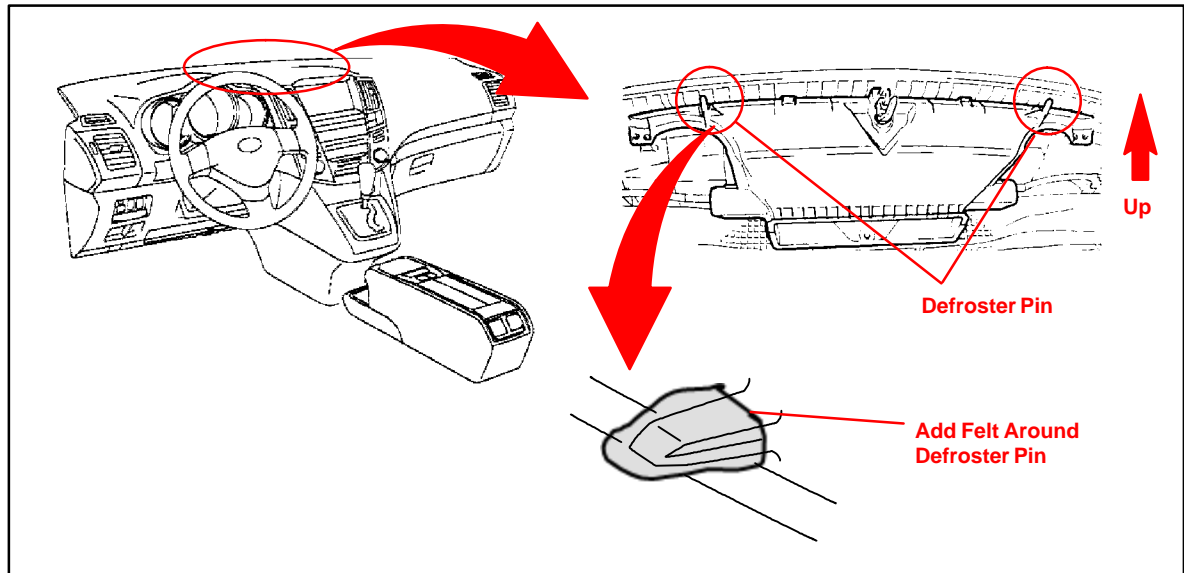
Introduction Some customers may experience rattle noises coming from the center of the instrument panel at the base of the windshield. The following procedure has been developed to improve the condition.

1. Follow the precautions and instructions to remove the dash pad sub-assembly as identified in the Technical Information System (TIS), applicable model and year Repair Manual: *Instrument Panel/Meter, Instrument Panel Safety Pad Sub-Assembly, Precaution and Replacement*.
2. Pull back the dash pad sub-assembly to expose the defroster nozzle assembly and its 2 locating pins.
3. Apply felt over the pins as shown in the diagram to take up excess slack inside the body holes.
Felt Size:
Length: 55 mm (2.2 in.)
Width: 13 mm (0.6 in.)
Thickness: 1.5 mm (0.1 in.)
4. Reassemble the dash pad sub-assembly.
