**Technical Service
Information Bulletin**

Title:
DASH RATTLE REPAIR

Models:
'04 – '05 RX 330

REVISÉD
NV007-04
NVH

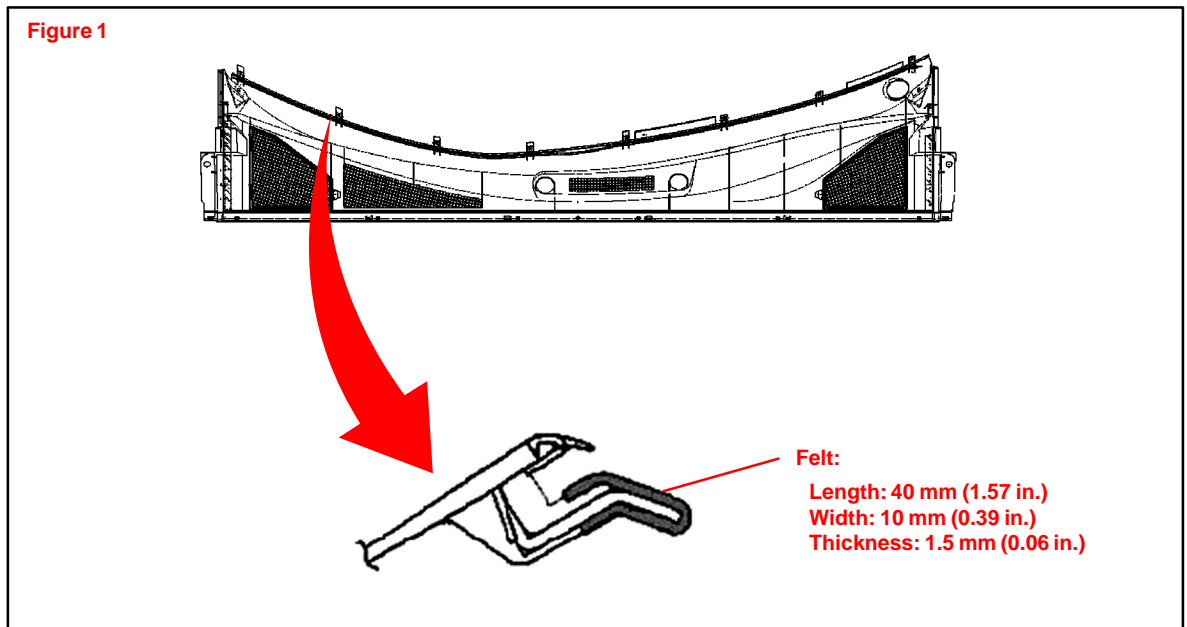
Repair Procedure 2 **Cowl Louver Area**

1. Remove cowl cover.
 - A. Follow the instructions in TIS, 2004 model year RX 330 Repair Manual: *Windshield/windowglass/mirror: Windshield Glass* for the removal of the cowl cover.

2. Cut 8 pieces of felt in the following dimensions:
Length: 40 mm (1.57 in.)
Width: 10 mm (0.39 in.)
Thickness: 1.5 mm (0.06 in.)
3. Wrap each of the 8 claws with felt.

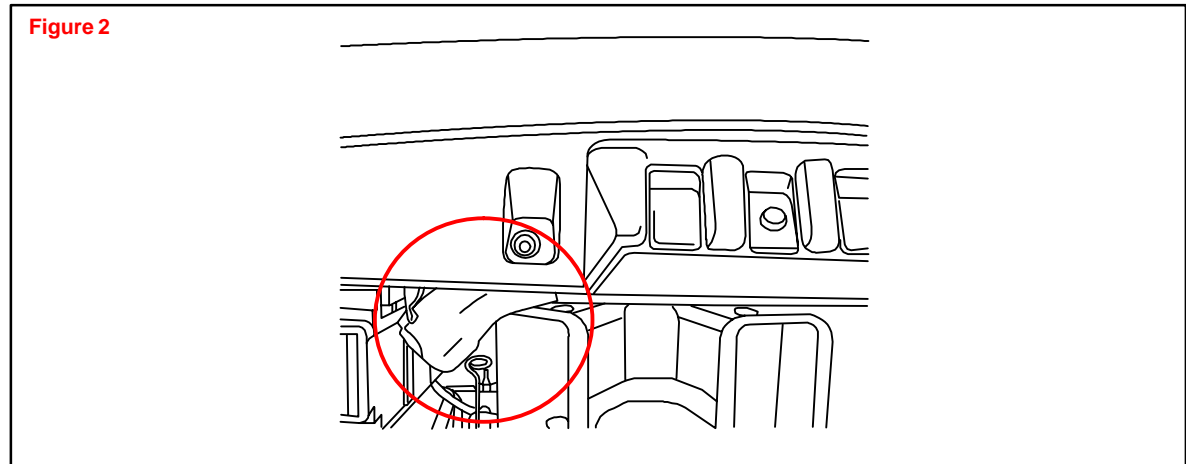
**Repair
Procedure 3****TRAC OFF Switch Area**

2. Locate the TRAC OFF switch wire harness that contacts the A/C duct for the floor.
3. Wrap the switch wire harness with sponge foam tape where contact between the wire harness and ducting is made.

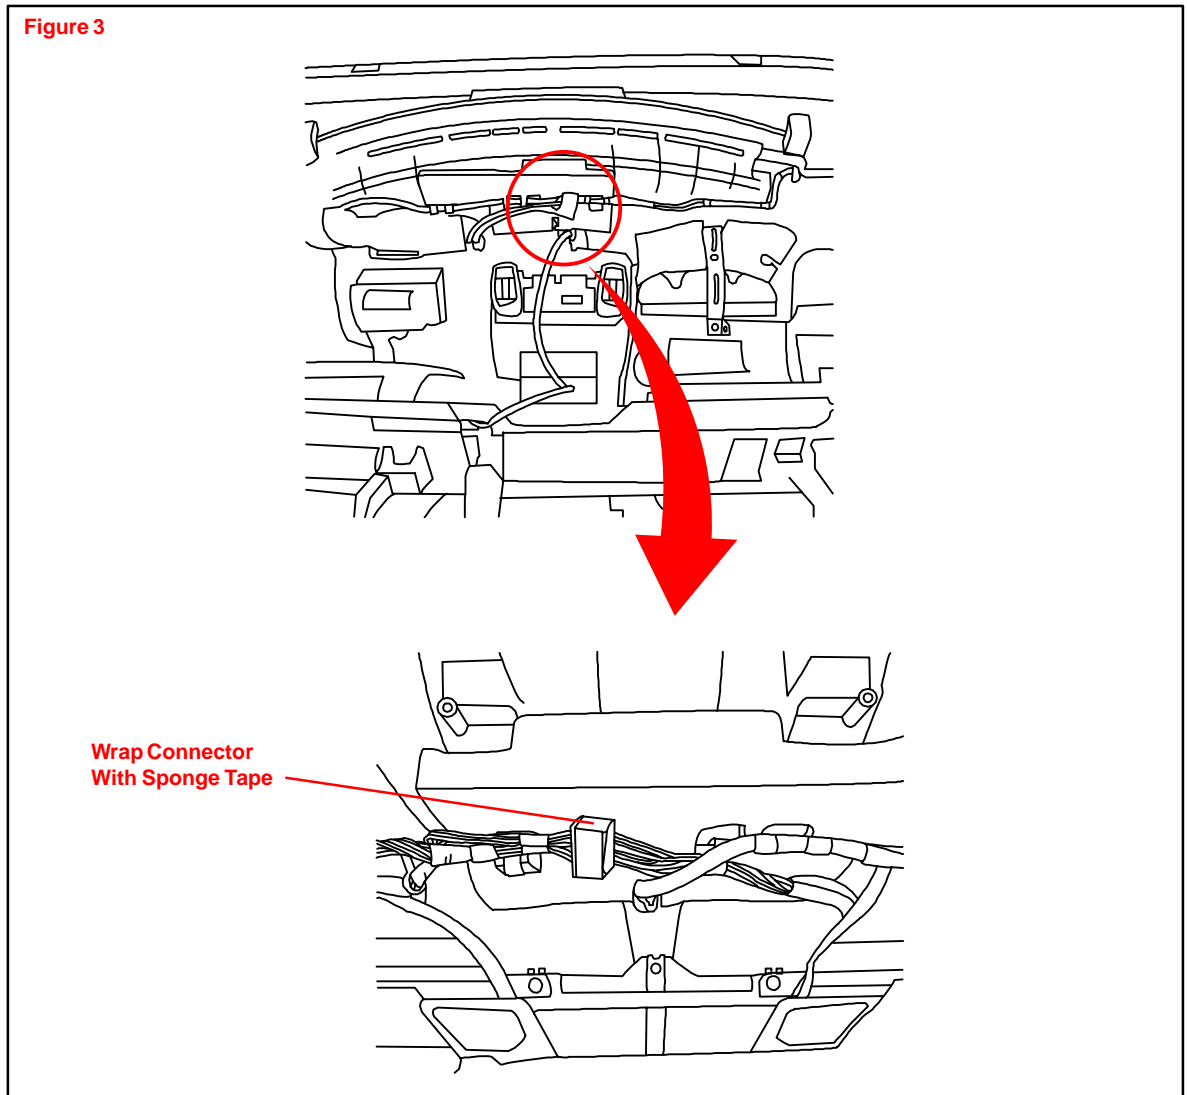
Figure 3

**Repair
Procedure 4****Defroster Duct (Wire Harness Above Duct)**

2. Flip dash pad so that it is upside down.
3. Locate instrument panel wire harness that runs along the underside of the dash pad above the defrost ducting.
4. Wrap connector using sponge foam tape.

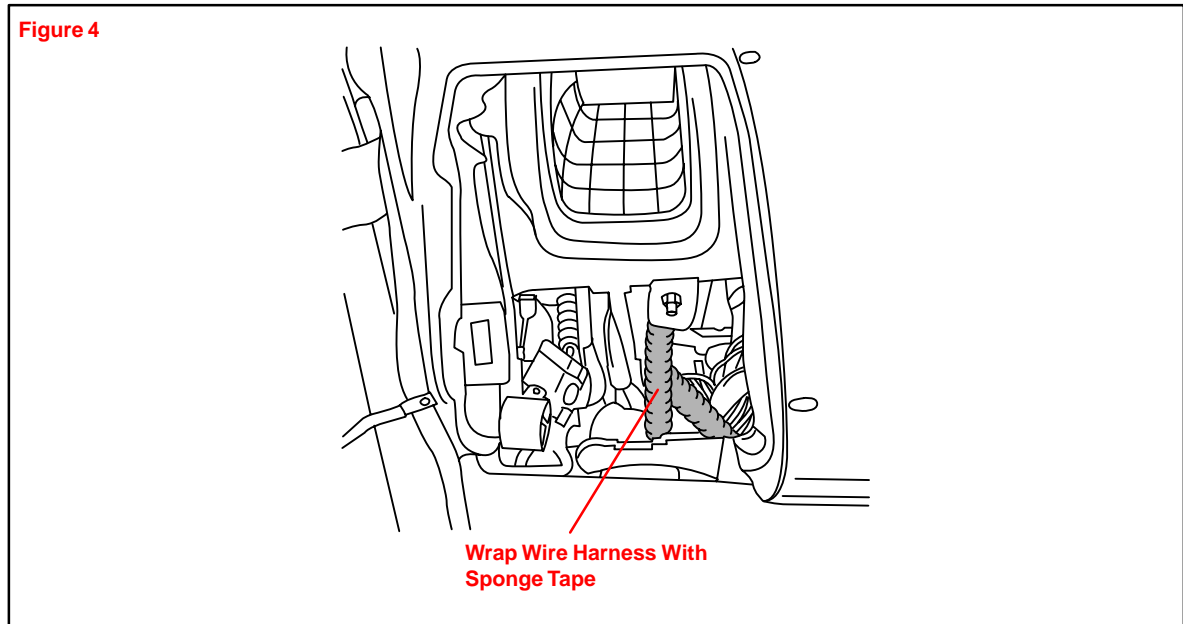
Repair Procedure 5 **Driver's Side Cup Holder Area**

2. Locate the remote control mirror switch wire harness where it contacts the cup holder.
3. Wrap sponge tape around remote control mirror switch wire harness where it contacts the cup holder.

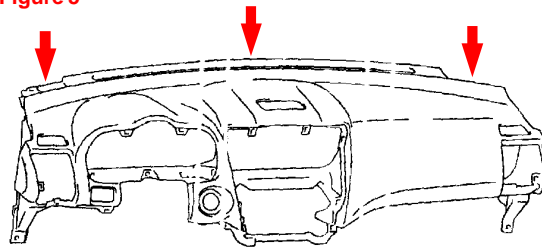
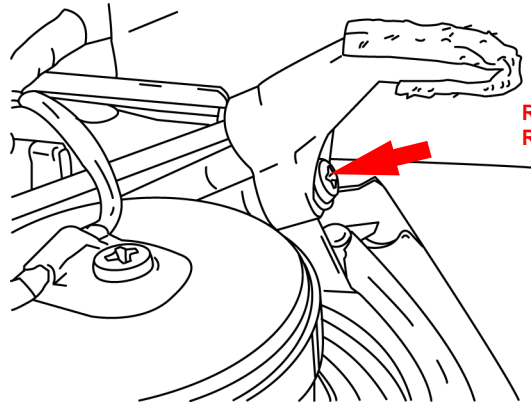
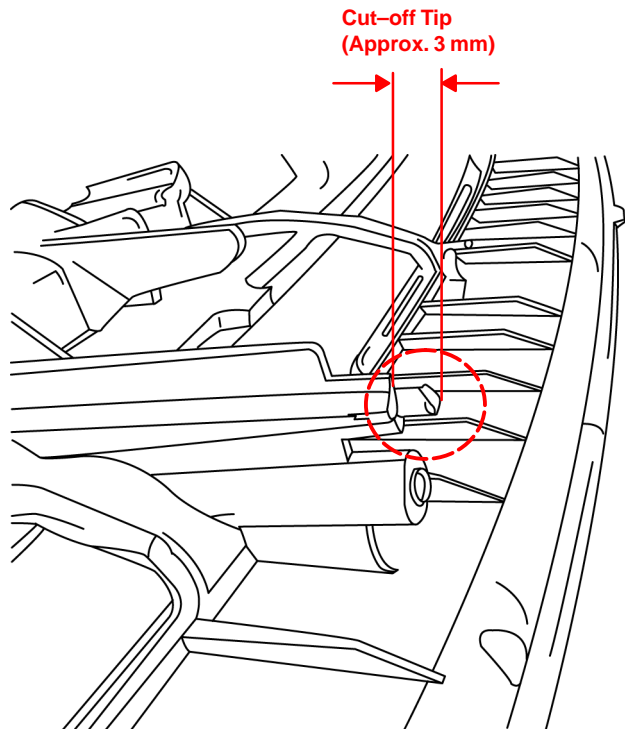
Remove Phillips-head Screw to Remove White Locating Clip

Cut-off Tip
(Approx. 3 mm)

1. Locate the 3 white insertion clips that contact the bulkhead.
2. Remove the 3 white insertion clips by removing the Phillips-head screws.
3. Cut off the tips of the pins under the insertion clips (refer to Figure 5 on page 9).
4. Reinstall the white insertion clips onto the dash pad using the previously removed screws.

5. Wrap felt around the white insertion clip, if not present, before reinstallation of the dash assembly into the vehicle.

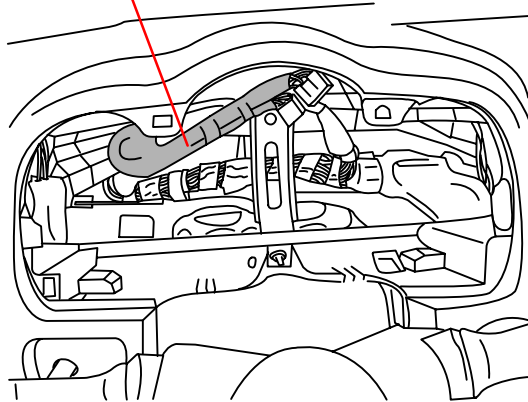
Figure 8

Wrap with Sponge Tape

2. Locate wire harness directly above the meter cluster.
3. Wrap felt tape around wire harness where contact is made with the meter cluster.
