**Technical Service
Information Bulletin**

MOON ROOF AND HEADLINER RATTLE SERVICE TIPS

'04 RX 330

NVH
NV009-03

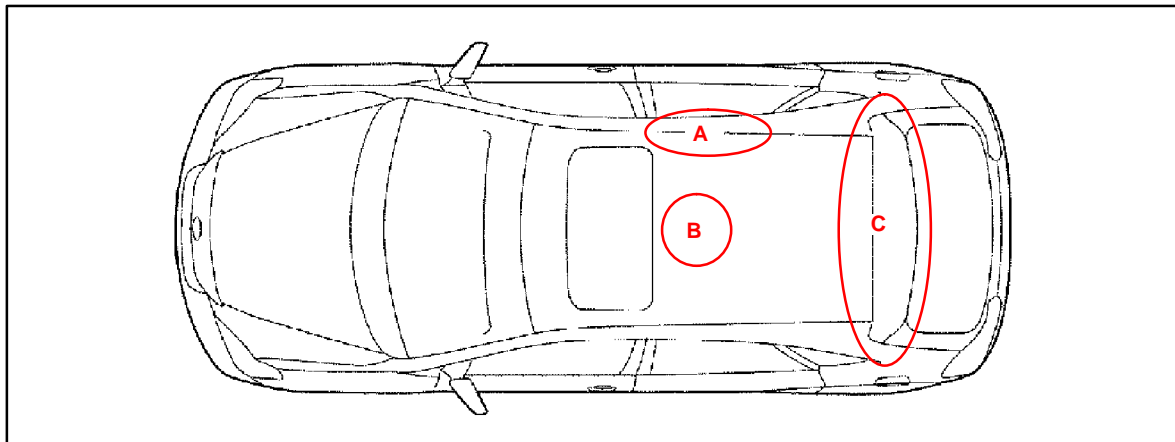
Introduction Some customers may experience rattling conditions from the headliner areas shown below, while driving or upon door closing. The following procedures have been developed to address these conditions.
