Technical Service Information Bulletin

GLOVE BOX RATTLE

'04 RX 330

NVH
NV012-03

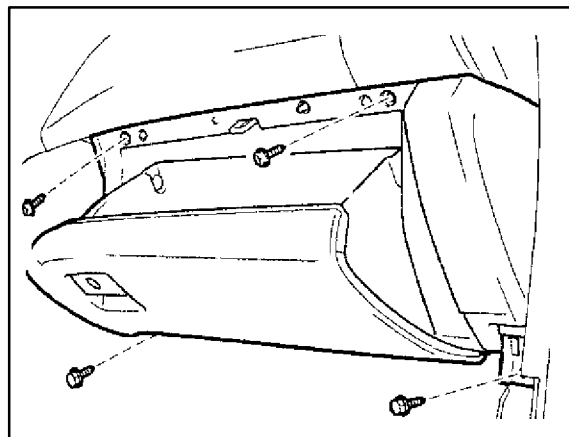
Introduction Some customers may experience a rattle from the bracket of the glove box area. The following procedure has been developed to reduce the noise.

1. Remove the glove box.
Refer to the Technical Information System (TIS) 2004 RX 330 Repair Manual: *Instrument Panel: Safety Pad Sub-assembly: Replacement.*
