**Technical Service  
Information Bulletin**

# HESITATION OR BUMP FEELING UPON ACCELERATION FROM A STOP

'07 LS 460/460L

TRANSMISSION & CLUTCH  
TC009-07

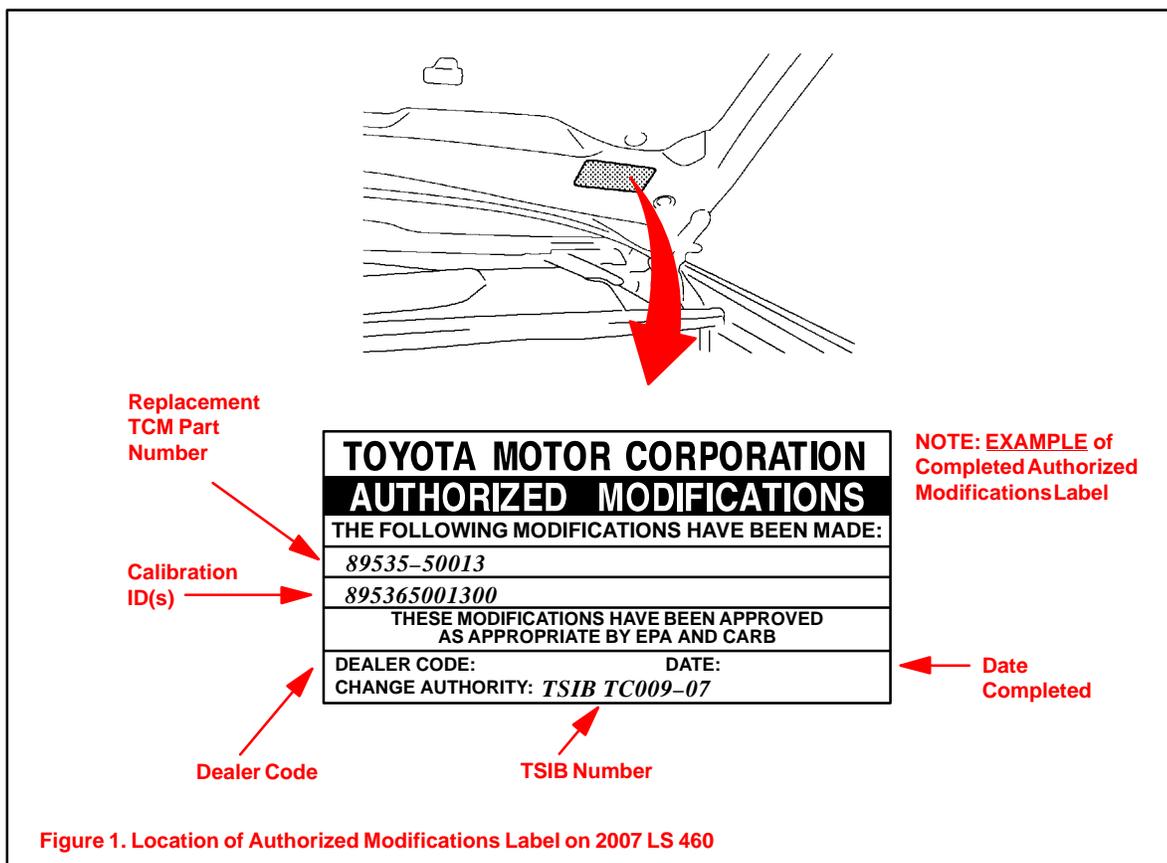
1. Check for the Authorized Modifications Label affixed to the vehicle in the location shown in Figure 1. Confirm if the TCM calibration has been updated. If the calibration ID listed is NOT the latest TCM calibration — go to step 2.

- B. Affix the Authorized Modifications Label to the vehicle at the location shown in Figure 1. The Authorized Modifications Label is available through the MDC, P/N 00451-00001-LBL.
- 4. The repair is complete. Test drive the vehicle to confirm normal operation.
- 5. Clear any DTCs that set during the reprogramming process.
