Technical Service Information Bulletin

M.I.L. "ON" DTC P0171 AND/OR P0174: ENGINE RUNNING LEAN

'04 RX 330

ENGINE
EG009-04

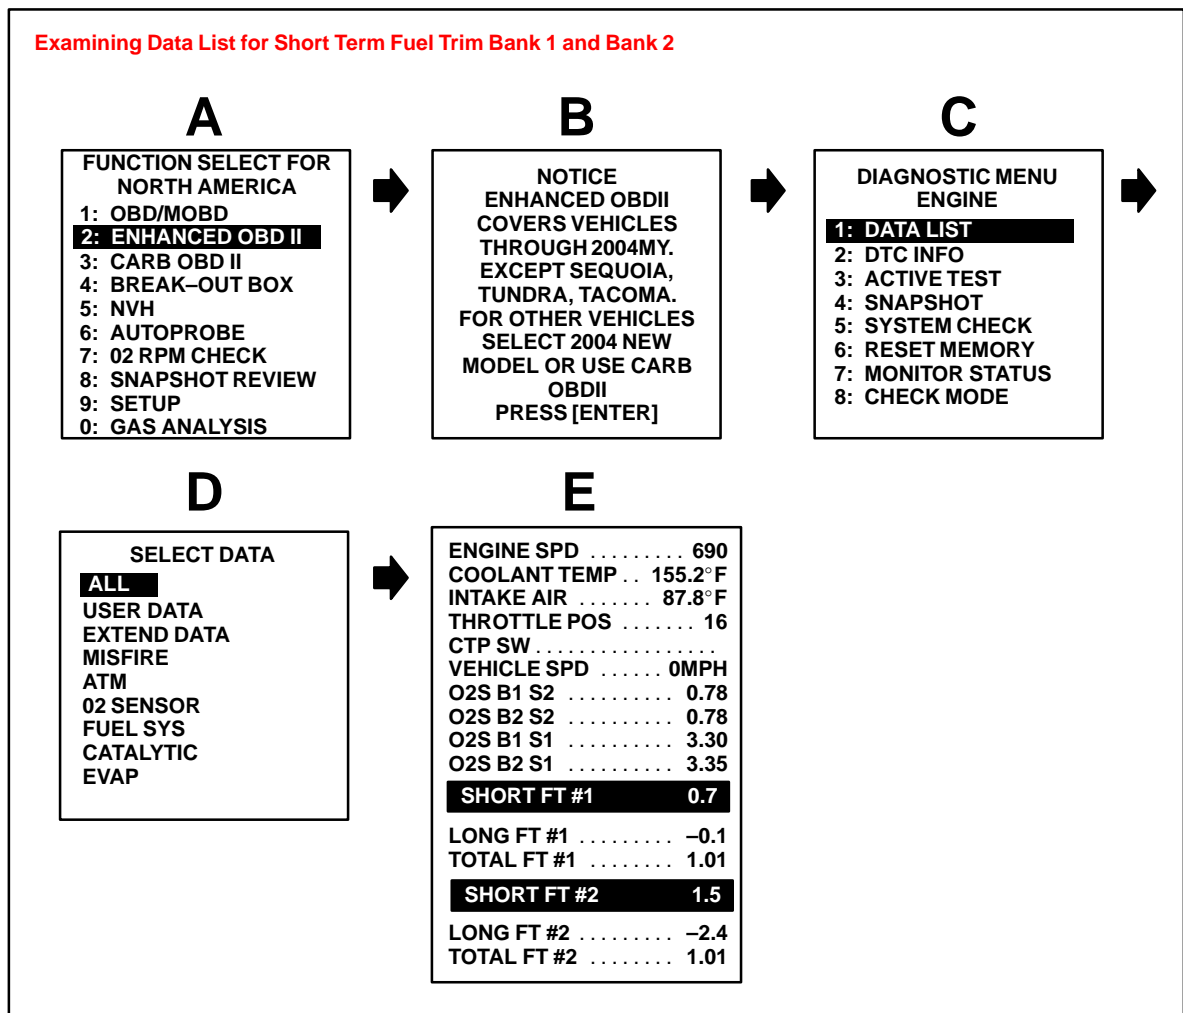
1. Monitor the Bank 1 and Bank 2 Short Term Fuel Trim in the Data List.

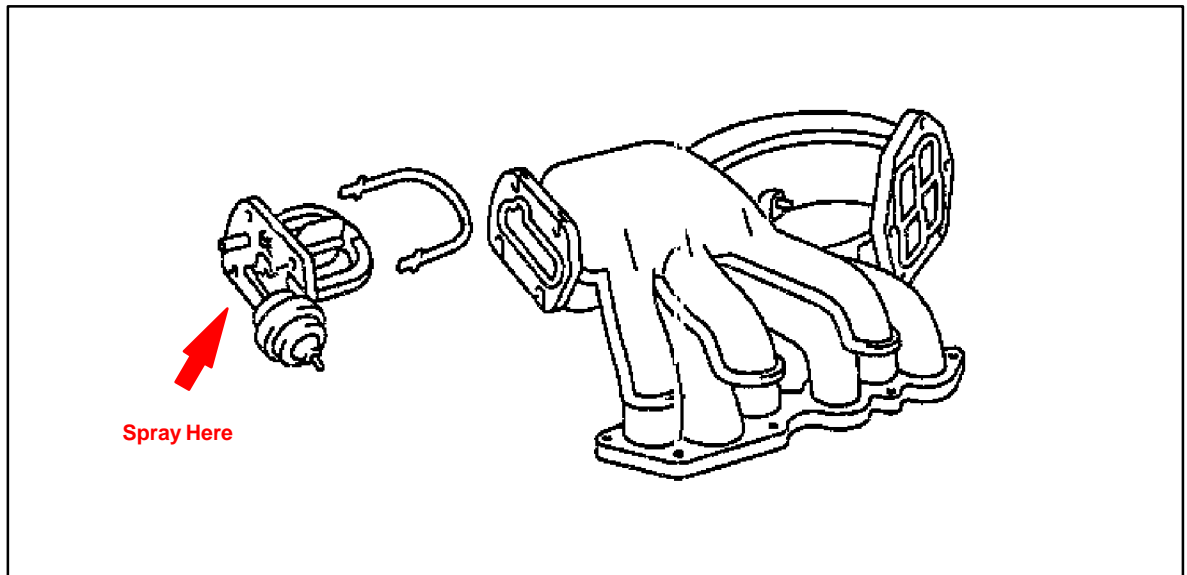
2. Spray carburetor cleaner near the Intake Air Control Valve pivot shaft and monitor Short Term Fuel Trim as indicated in step 1.

If Yes – Replace the Intake Air Control Valve. Refer to the Technical Information System (TIS), 2004 model year RX 330 Repair Manual: *Intake: Intake Air Control Valve Assy No. 2 (3MZ-FE): Replacement*.
