**Technical Service
Information Bulletin**

Title: **ENGINE IDLE KNOCK NOISE**

Models: **'07 LS 460/460L**

**ENGINE
EG014-07**

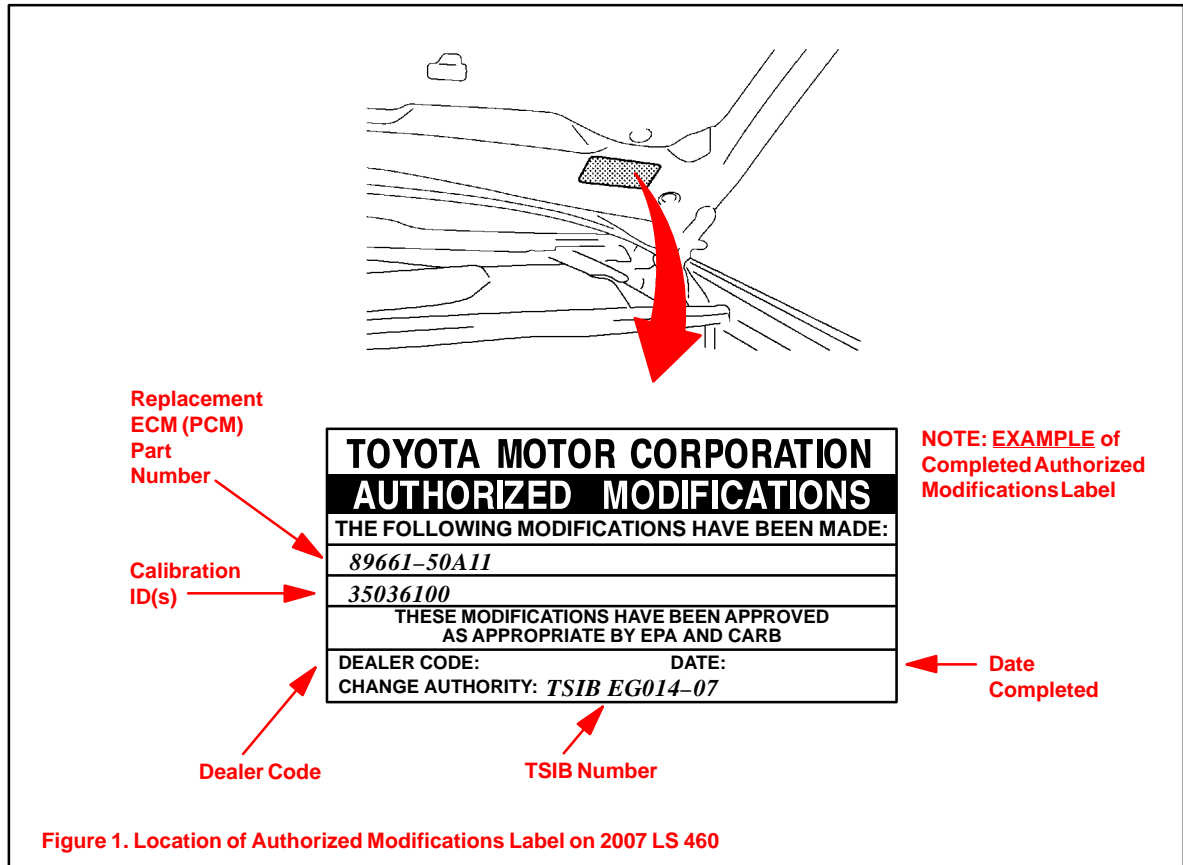
1. Check for the Authorized Modifications Label affixed to the vehicle in the location shown in Figure 1. Confirm if the ECM (PCM) calibration has been updated. If the calibration ID listed is NOT the latest ECM (PCM) calibration — go step 2. If the calibration ID listed is the latest ECM (PCM) calibration — go to Repair Procedure B.
