BE-0002L-0110-EN

Technical Service Bulletin

Water leaking into cabin due to blocked air conditioning drain tube

IS220d, IS250, GS300, GS430, GS450h

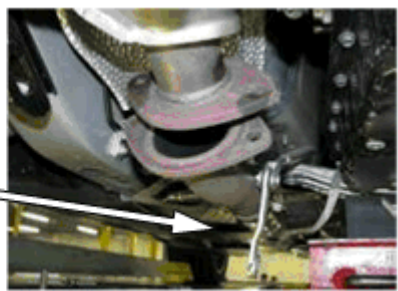
5. Support the T/M mount with a T/M Jack and lower T/M for 40mm.

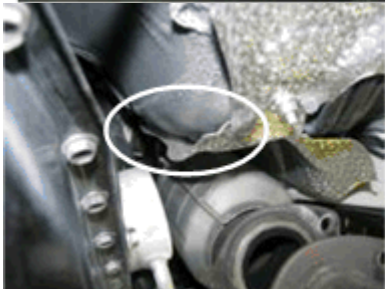
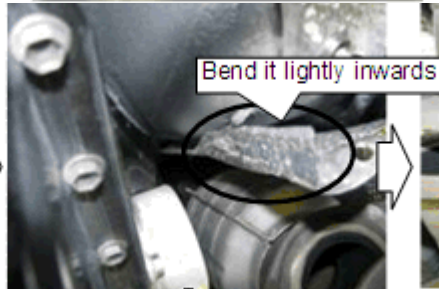
7. Remove insulators or bend them away to prevent injuries and to make more space.

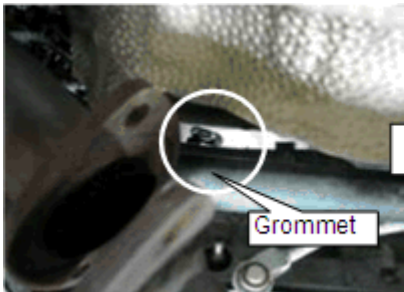
8. Confirm A/C drain position

8.1 by visual confirmation:

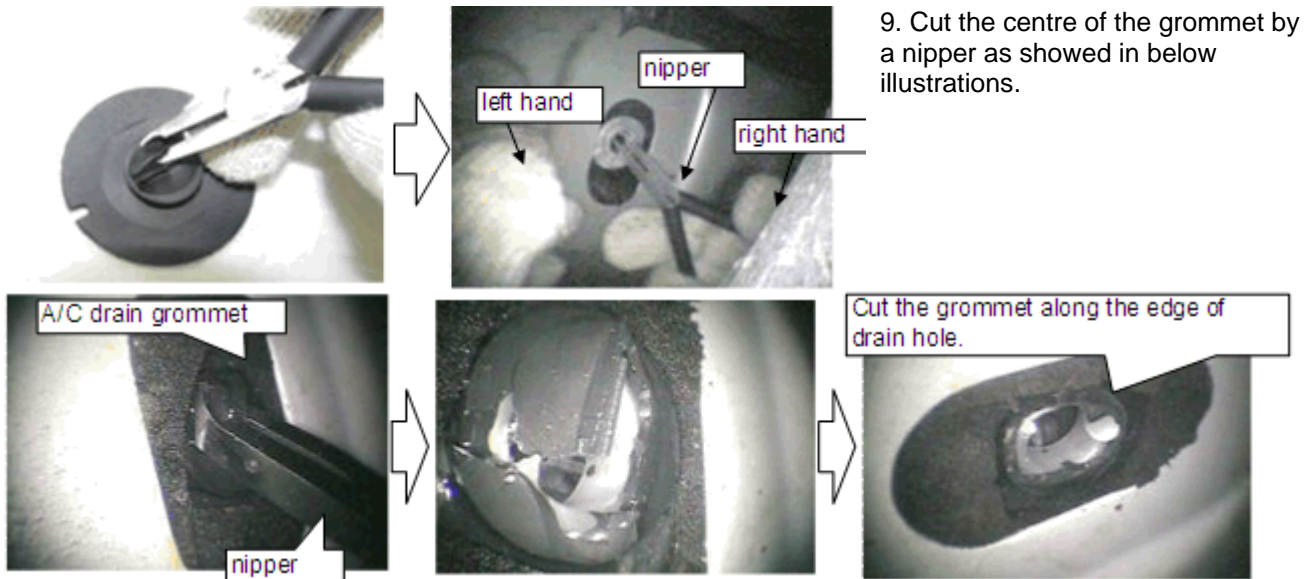
9. Cut the centre of the grommet by a nipper as showed in below illustrations.

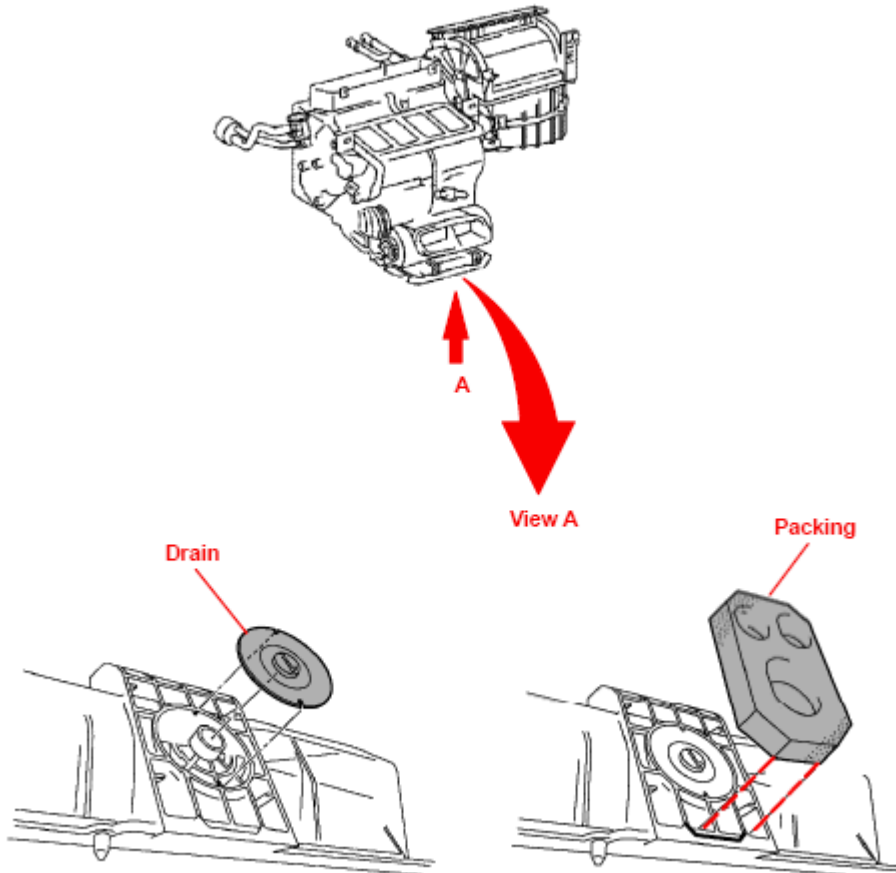
- 1. Remove the air conditioning unit.
Refer to TechDoc for R&R of air conditioning unit.
- 2. Remove the HVAC evaporator drain and packing.

- 3. Install the NEW HVAC evaporator drain and packing to the air conditioning unit.
- 4. Install the air conditioning unit.
