BO-0074L-0710-EN

Technical Service Bulletin

Unusual interior noises from instrument panel area

GS300, GS430, GS350(4WD), GS450h, GS460

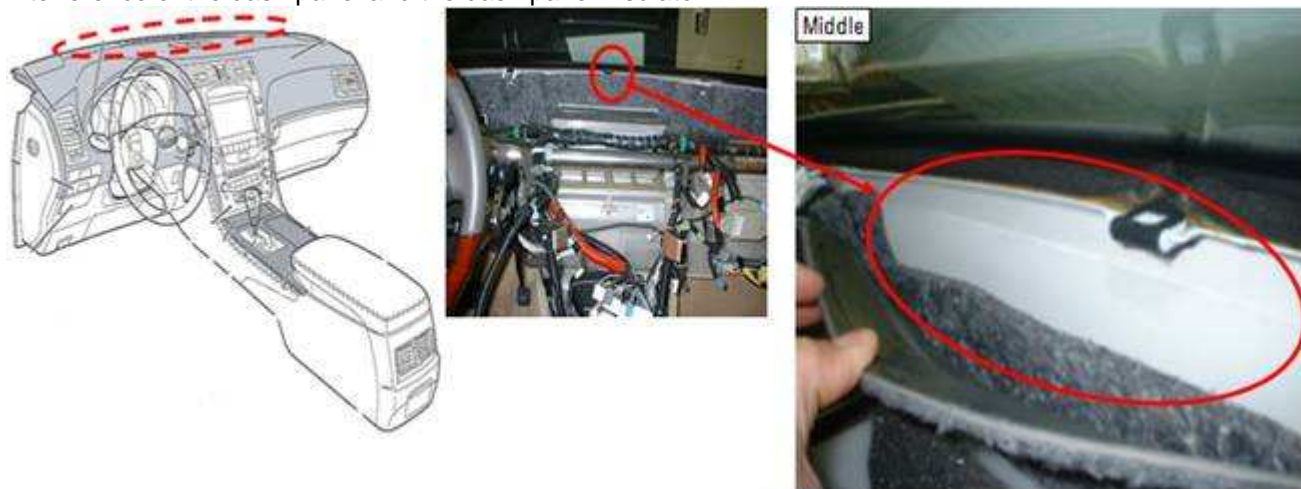
Item 1: Abnormal noise from dash panel.

Rattle noise from back center of the instrument panel while driving on continuing small bumps.

Interference of the dash panel and the dash panel insulator.

Attach the caulking sponge on dash panel centre portion.

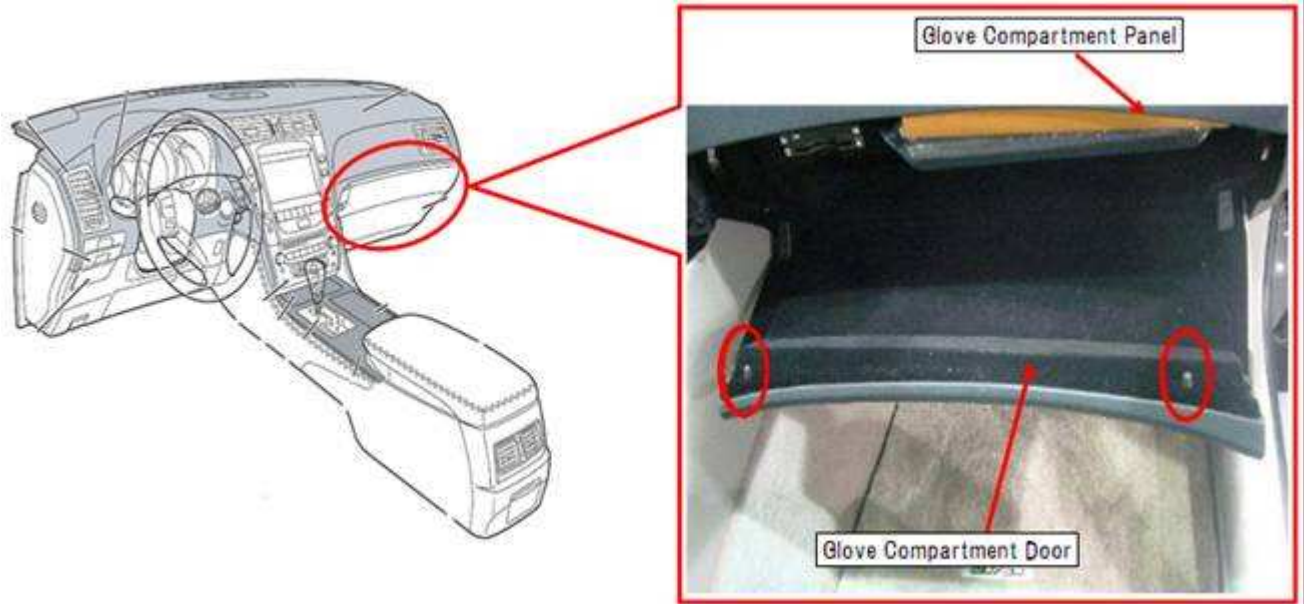
Item 2: Abnormal noise from glove compartment door.

Continuous rattle noise from the glove box while driving on a bumpy road.
The noise disappears when holding the glove compartment door.

Looseness due to a gap between the glove compartment door and the glove compartment panel.

- ① Remove the glove compartment door check cushion from the glove compartment door.
- ② Place washers and install again.

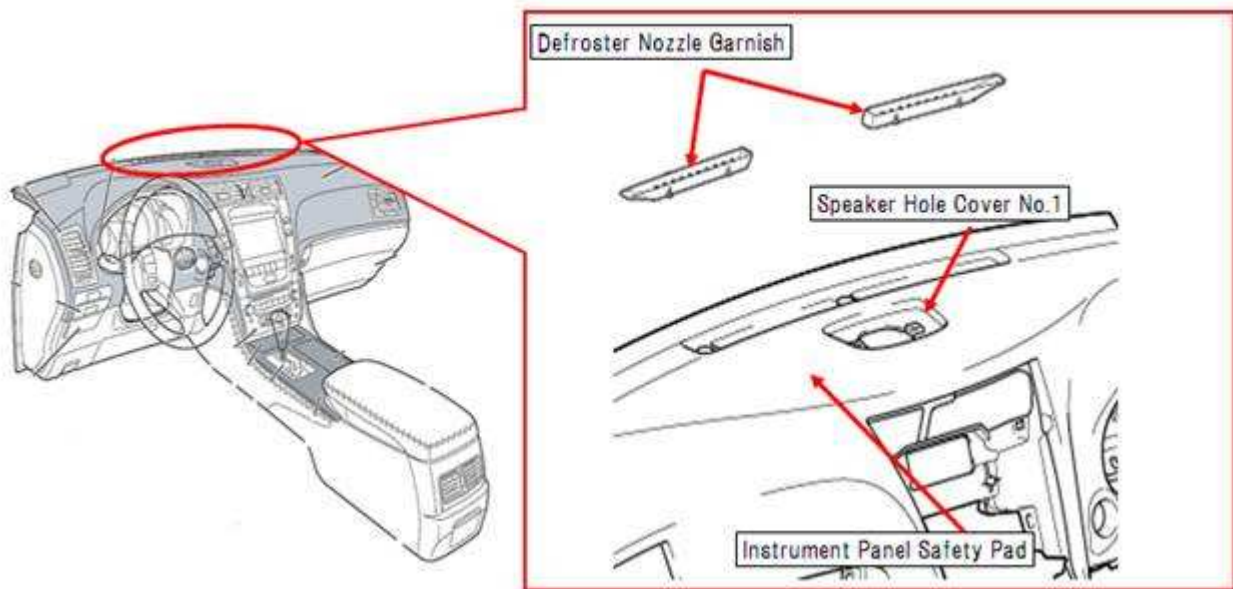
Item 3: Abnormal noise from defroster nozzle garnish.

Click/crack/clap noise around the centre of the instrument panel while driving on bumps with difference in height or joints of roads.

Interference of the defroster nozzle garnish and the instrument panel safety pad.

Attach felt tape on craws of the defroster nozzle garnish, which is located on the instrument panel safety pad (Total 8 locations, 4 locations on each side)

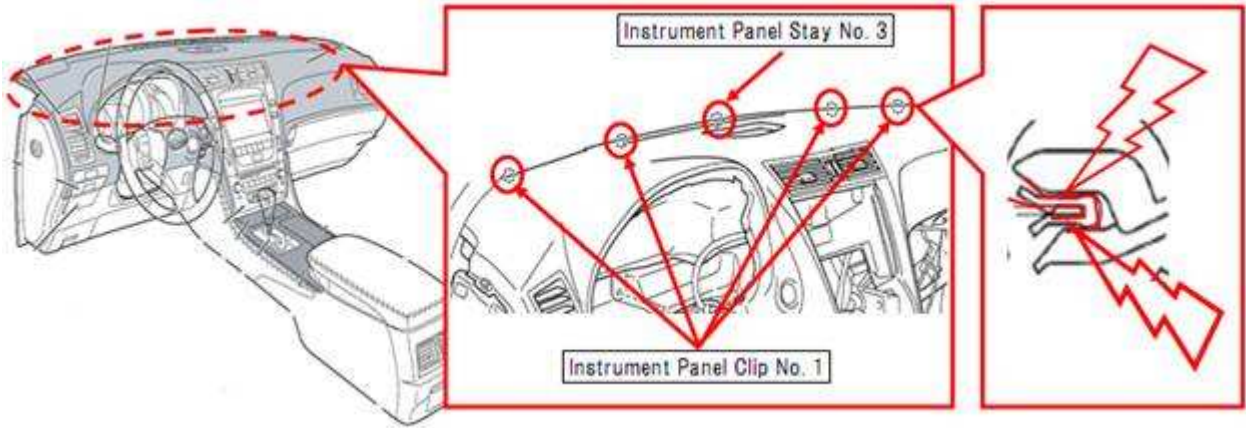
Item 4: Abnormal noise from instrument panel clip.

Rattle/creak/clap noise from the top of the instrument panel safety pad while driving on a bumpy road.

- (1) Looseness in the fitting portions of the instrument panel safety pad and the instrument panel clip No. 1 & instrument panel stay No. 3.
- (2) Looseness between the instrument panel clip No. 1 & instrument panel stay No. 3 and the front panel.

- Apply felt tape on the instrument panel clip No. 1 and the instrument panel stay No. 3
- Cut the felt into the size shown below and attach it.

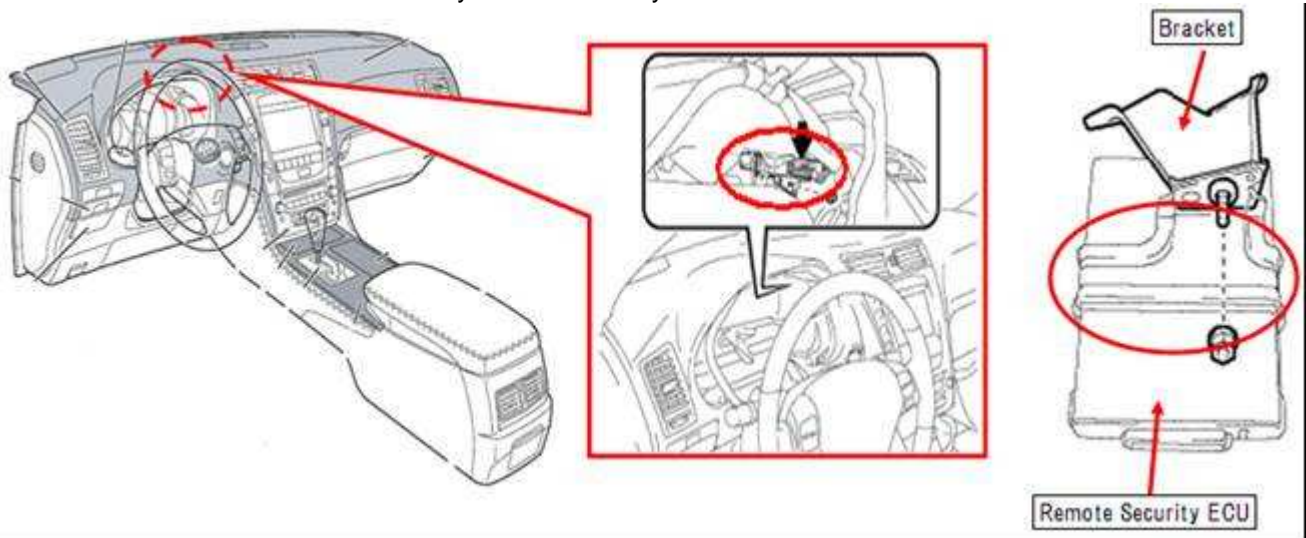
Item 5: Abnormal noise from remote security ECU.**Symptoms & Conditions:**

Rattle and beating noise around the centre of the instrument panel during driving on a bumpy road.

Looseness between the remote security ECU main body and the bracket.

Place caulking sponge between the remote security ECU and the bracket.

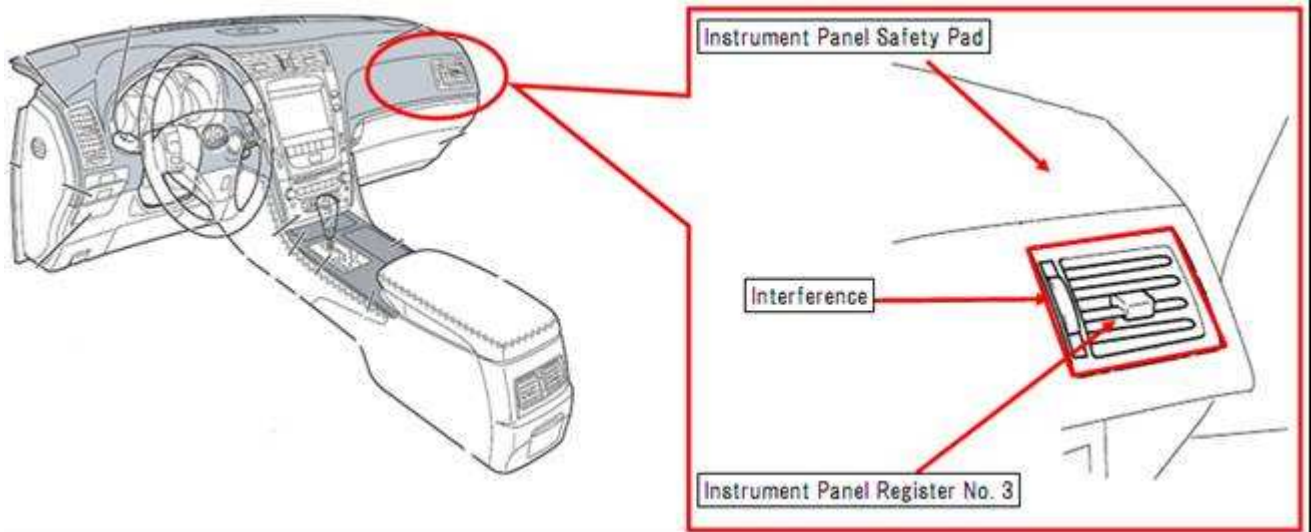
Item 6: Abnormal noise from instrument panel register No. 3.

Squeak/creak noise at the passenger's seat while driving on a rough road or a bump.
Noise cannot be eliminated by holding the instrument panel on top of the register.

Interference of the instrument panel safety pad and the instrument panel register No. 3.

Attach felt tape to the front edge periphery of the instrument panel register No. 3.

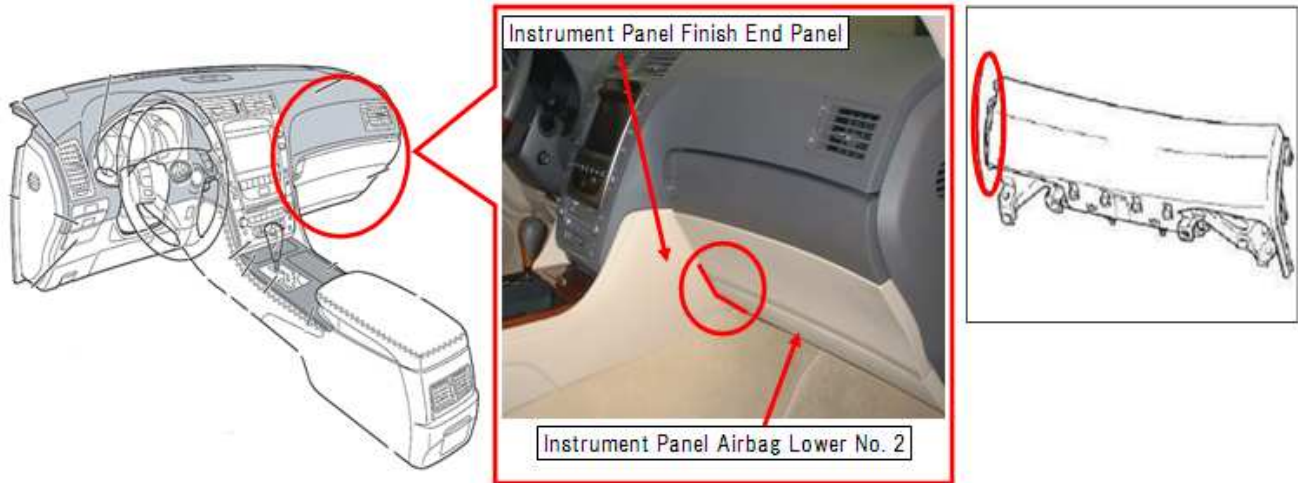
Item 7: Abnormal noise from instrument panel airbag lower No. 2.

Creaking noise around the passenger seat when passing through bumps.

Interference of the joint area of the instrument panel airbag lower No. 2 and the instrument panel finish panel end.

Attach felt tape and EPT sealer on the joint area of the instrument panel airbag lower No. 2 and the instrument panel finish panel end.

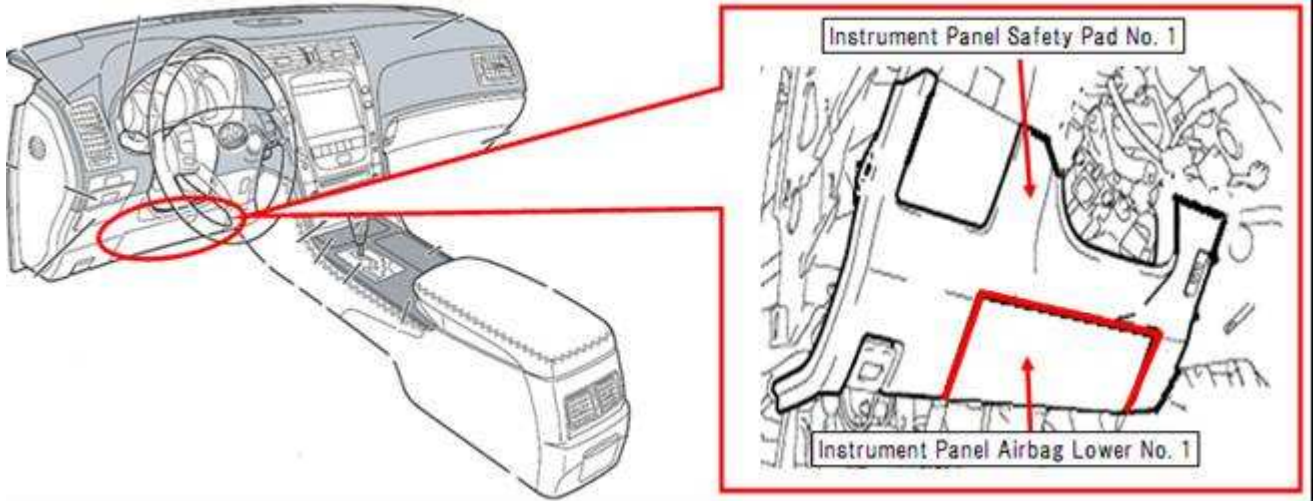
Item 8: Abnormal noise from instrument panel safety pad No. 1.

Beating noise from driver's seat foot space while driving on small bumps or rutty roads.

Interference of the joint and contact areas of the instrument panel safety pad No. 1 and the instrument panel air bag lower No. 1.

Attach felt tape on the contact area and clips of the instrument panel safety pad No. 1.

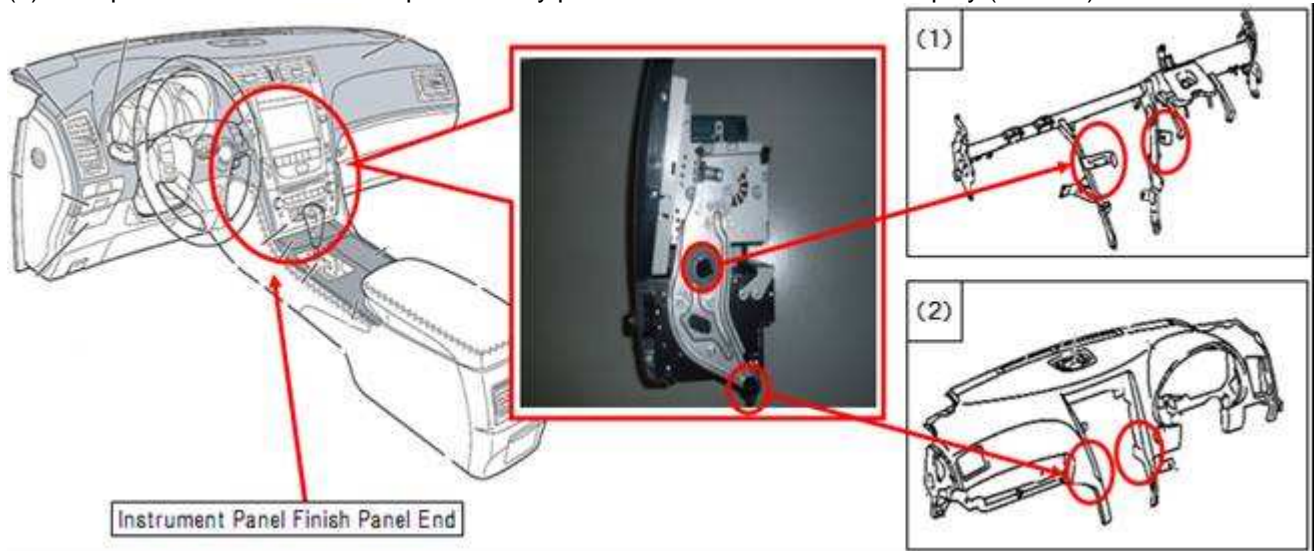
Item 9: Abnormal noise from multimedia module display.

Creaking noise from the meter periphery while driving.
The noise disappears when holding the instrument panel finish panel end.

Friction between the multimedia module display and the following parts:

- (1) Joint area of the instrument panel reinforcement and the multimedia module display.
- (2) Joint portion of the instrument panel safety pad side multimedia module display (Bracket).

Apply felt tape to the mounting bolt hole of the multimedia module display (4 locations).

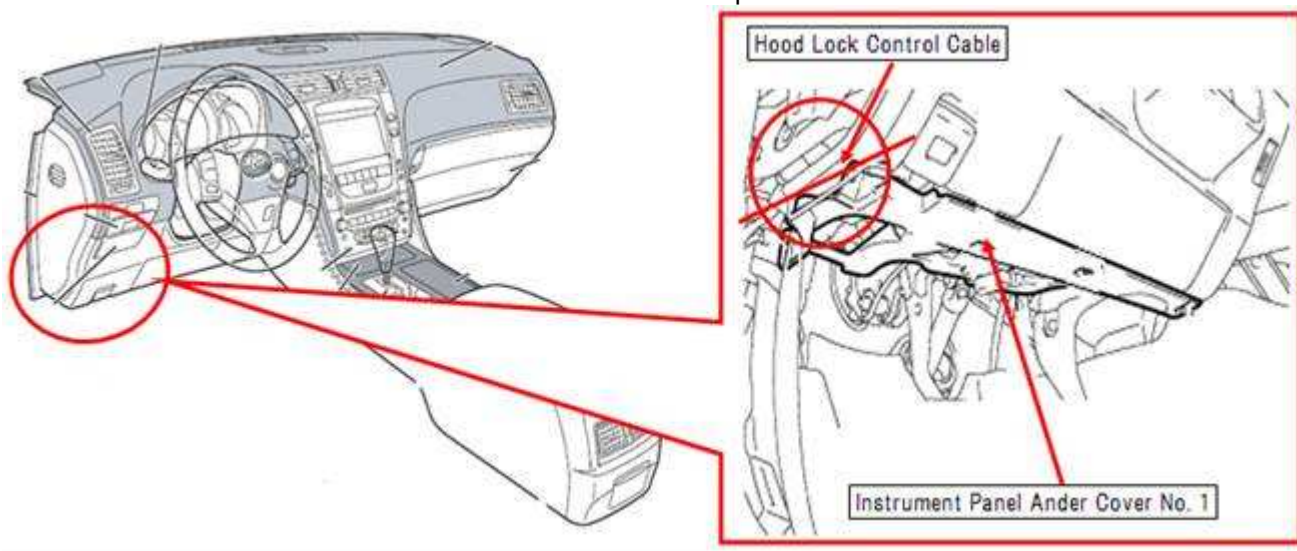
Item 10: Abnormal noise from hood lock control cable**Symptoms & Conditions:**

Rattle noise around the instrument panel under cover No. 1.
Continuous occurrences after it occurs once.

Interference of the hood lock control cable and the instrument panel under cover No. 1.

Cover the hood lock control cable with caulking sponge.

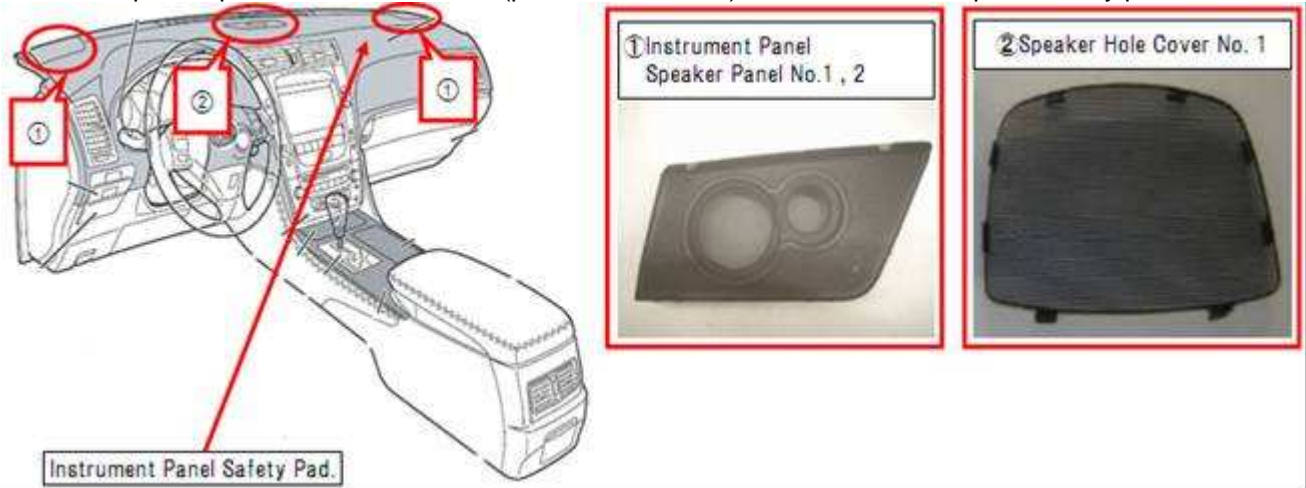
Item 11: Abnormal noise from instrument panel speaker hole cover.

Creak/ rattle/ crack noise from top of the instrument panel while driving on a bumpy road.

Interference of the instrument panel speaker hole cover No.1 (panel No.1 & No.2) and the wire netting, or the instrument panel speaker hole cover No.1 (panel No.1 & No.2) and the instrument panel safety pad.

1. Attach felt tape on whole circumference of the instrument panel speaker cover housing top surface

2. Attach felt tape on whole circumference of the instrument panel speaker cover housing end (Onto the fixed metal netting)

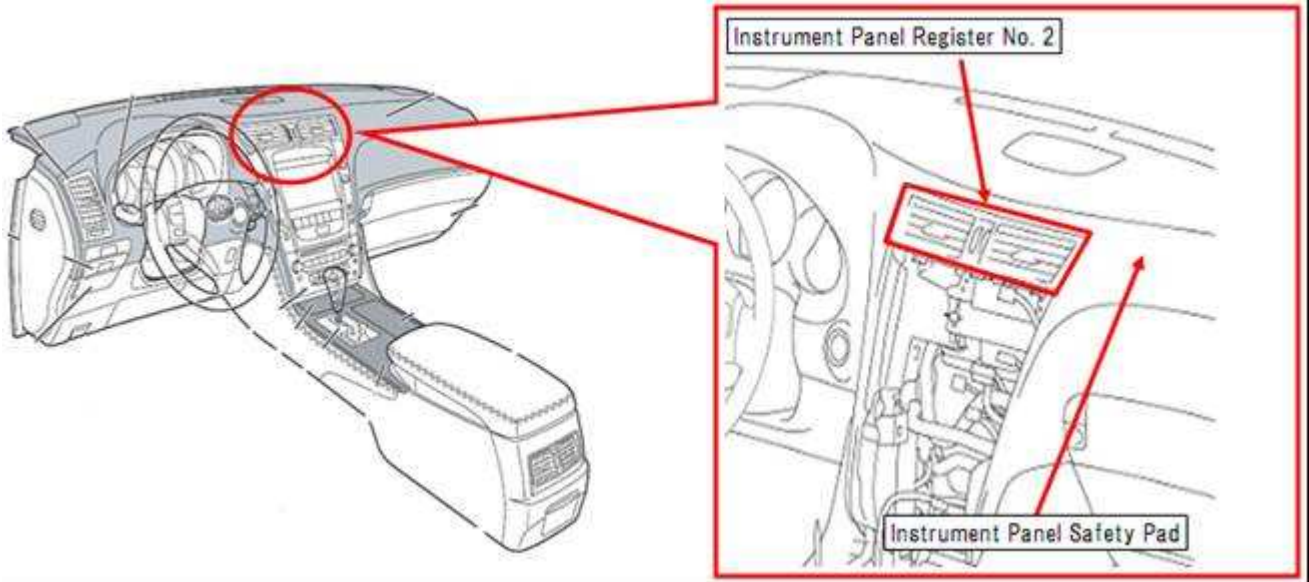
Item 12: Abnormal noise from instrument panel register No. 2.

Vibration noise around the centre of the instrument panel while driving on bumpy roads.
The noise disappears by placing hands on the instrument centre register No. 2.

Interference of the instrument panel register No. 2 and the instrument panel safety pad or the multi display.

Attach caulking sponge and EPT sealer on the periphery of the instrument panel register No. 2.

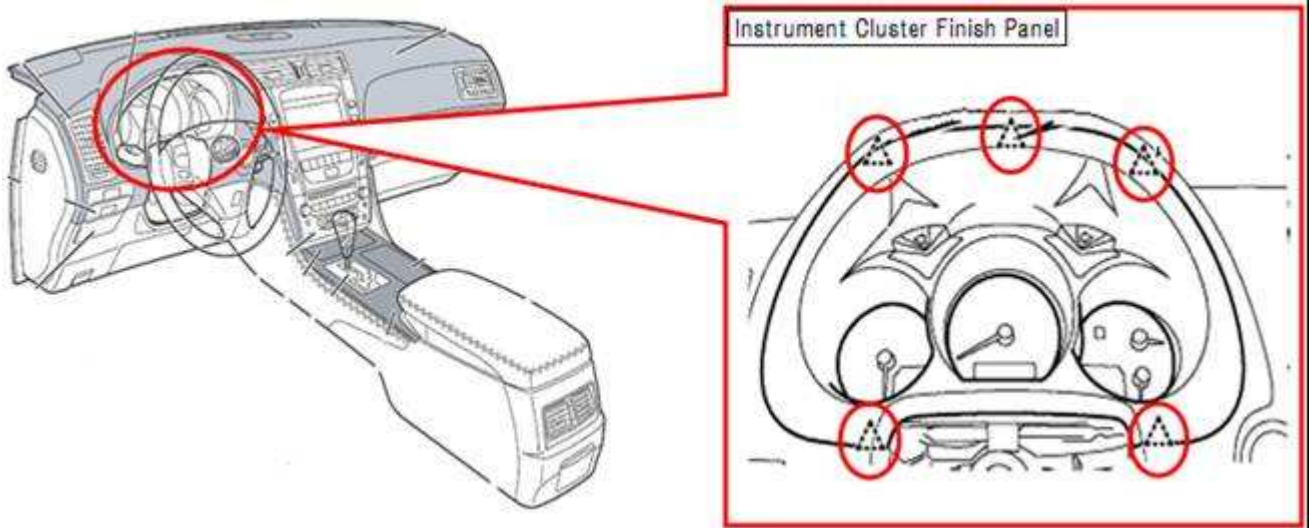
Item 13: Abnormal noise from instrument cluster finish panel.

Rattle noise around the combination meter while driving on bumpy roads.
The noise disappears by placing hands on the cluster finish panel.

Looseness in claws and clips on the instrument cluster finish panel.

Cover claws and clips on the instrument cluster finish panel with felt tape.

If the clips are removed, it is highly possible that the clip attachment portions may break and new parts will be required as a result. If they are not removed, it is advisable to adhere or fix clips with adhesive or Seal Packing Black.

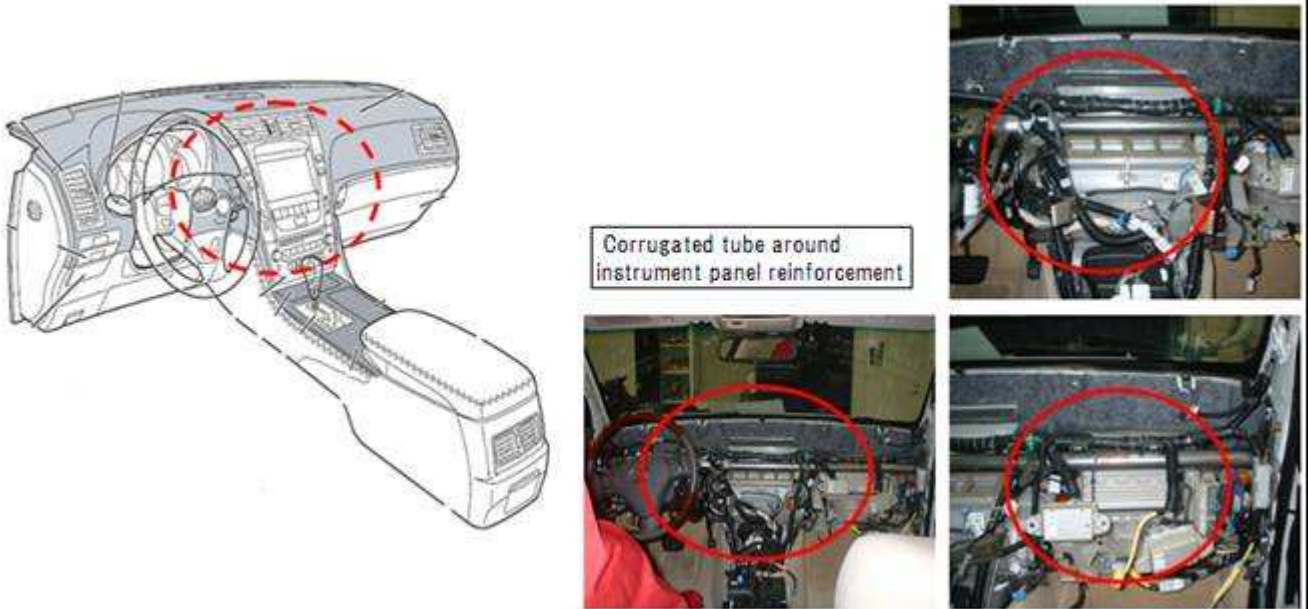
Item 14: Abnormal noise from corrugated tube.**Symptoms & Conditions:**

Squeak noise from the center back of the instrument panel while passing bumps or joints on roads
It tends to occur first in the morning or at night where the vehicle is cold.

Friction of corrugated tube opening sections around the instrument panel reinforcement.

Fix the opening portion of the corrugated tube with vinyl tape.

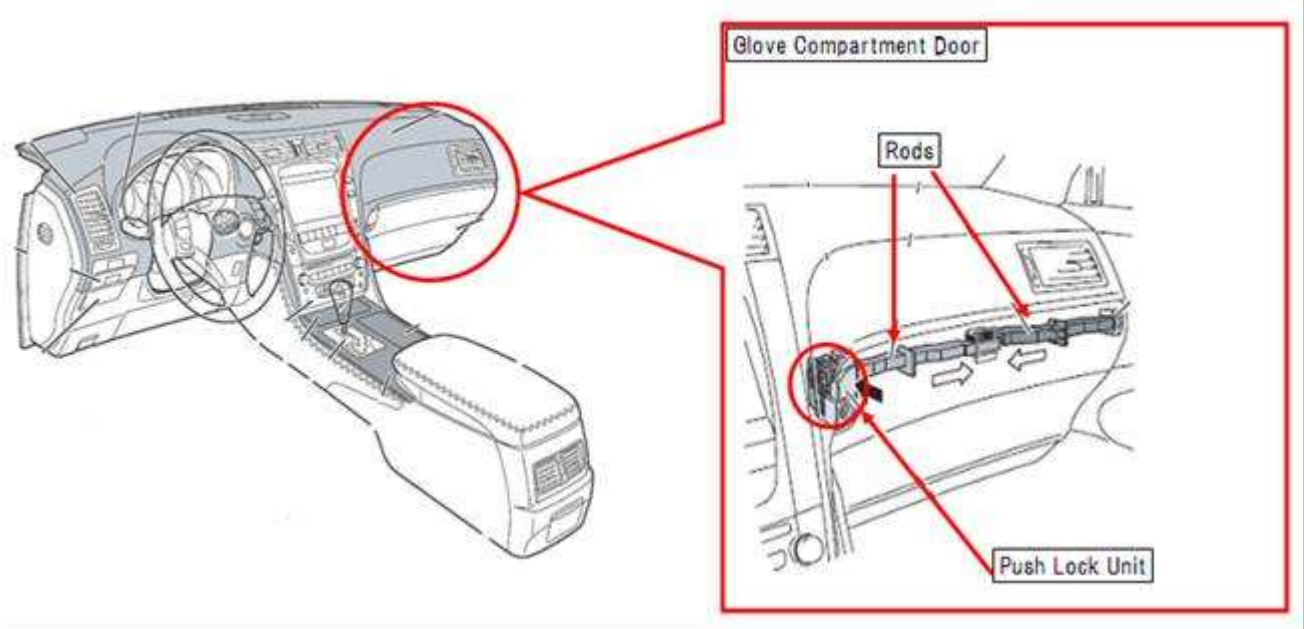
Item 15: Abnormal noise at glove compartment door lock.

Rattle noise at glove box while driving a rough road.

The noise disappears when opening the glove compartment door.

Looseness in the rods and the push lock unit of the glove compartment door lock portion.

Attach felt tape on the rod side and the push lock unit side of the glove compartment door lock portion.

Notice: This may impair the appearance as the felt tape will be visible.

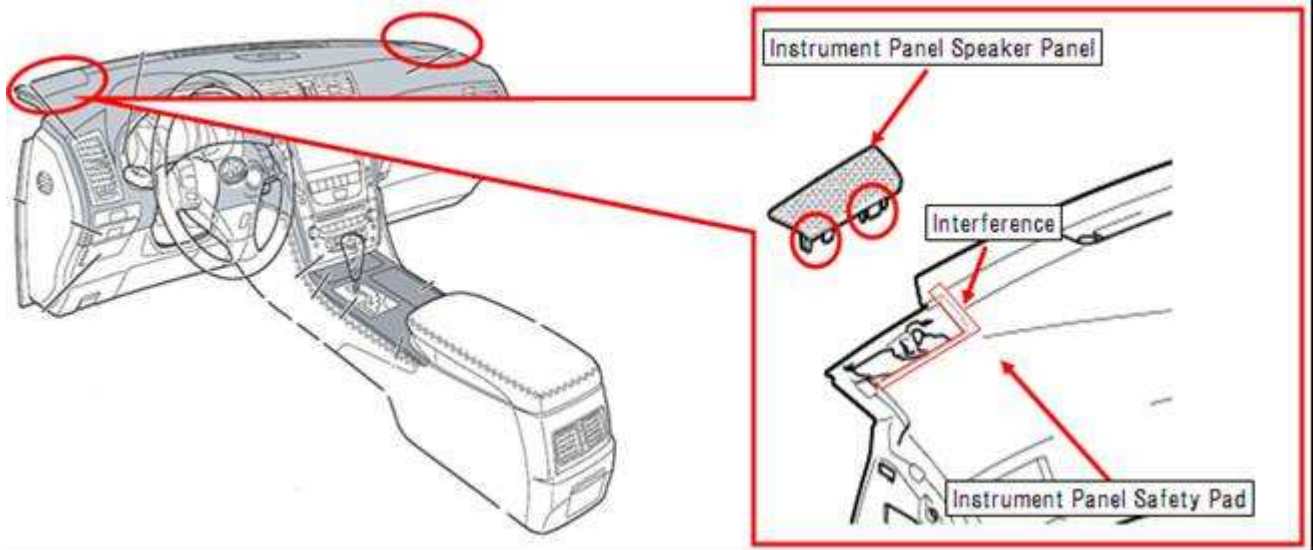
Item 16: Abnormal noise from instrument panel speaker panel.**Symptoms & Conditions:**

Rattle noise at the top of the instrument panel while driving on a bumpy road.

Looseness in clips & claws of the instrument panel speaker hole cover and the instrument panel safety pad.

Cover the clips and claws of the instrument panel speaker hole cover with felt tape.

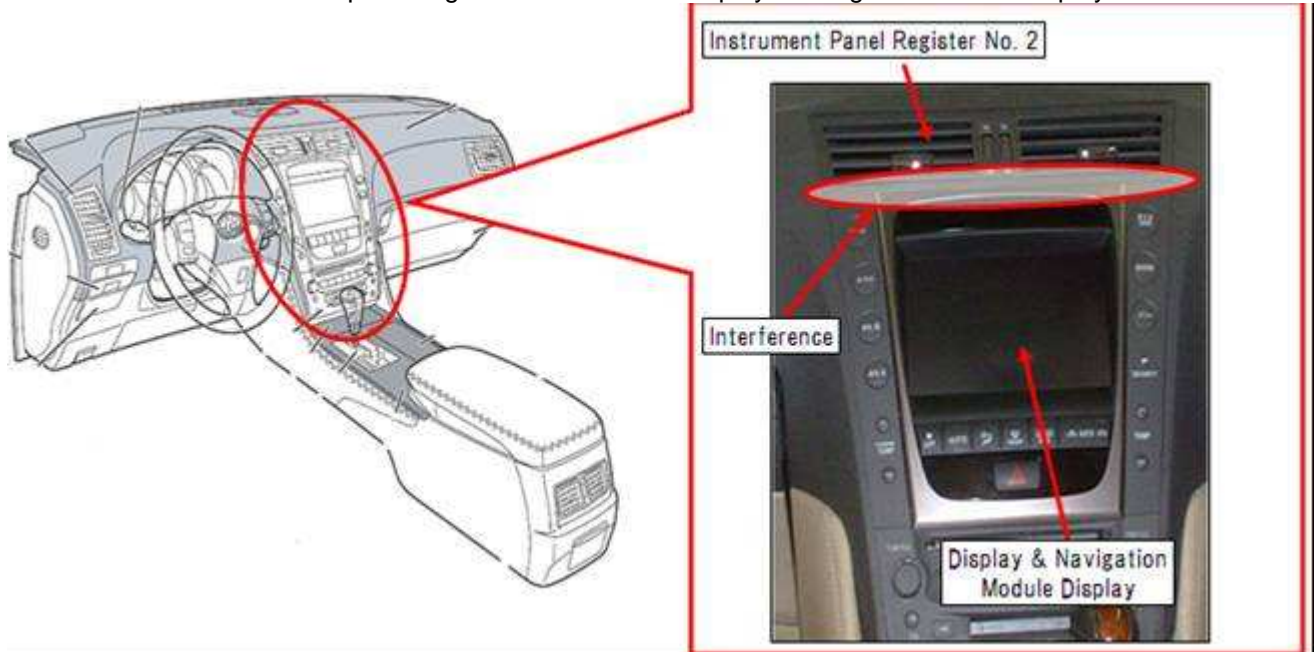
Item 17: Abnormal noise from instrument panel register No. 2

Rattle noise from the center console near the audio when the vehicle is going over bumps.
The noise disappears while driving after removing the audio and the instrument panel register No. 2.

Looseness in the instrument panel register No. 2 and the display & navigation module display.

Cover craws and clips under the instrument panel register No. 2 with felt tape.

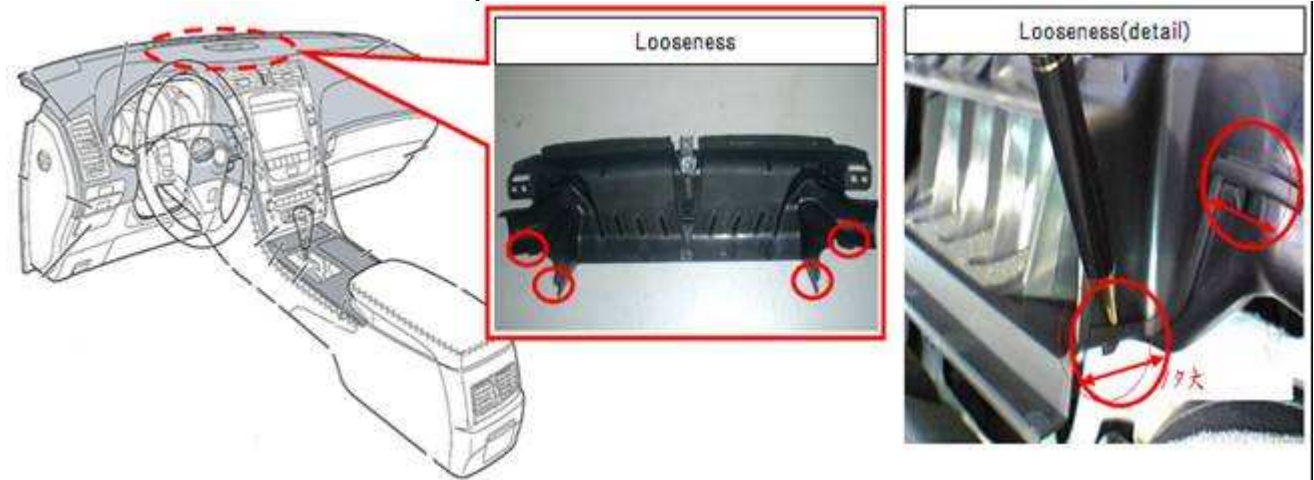
Item 18: Abnormal noise from instrument panel register No. 2

Creaking noise around the center speaker during driving on a rough road.

Looseness in the defroster nozzle craw joint surface.

Disassemble the defroster nozzle and attach the felt tape on each craw and joint surface.

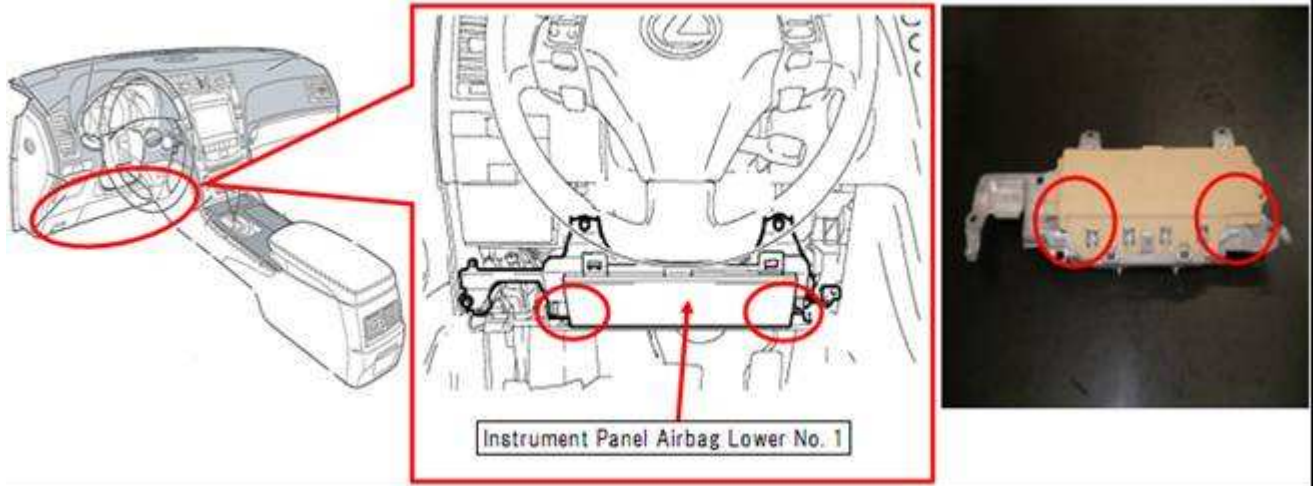
Item 19: Abnormal noise from instrument panel airbag lower No. 1

Rattle noise from driver's seat foot space while driving.

Interference of the instrument panel airbag lower No. 1 cover and the bracket.

- ① Remove the cover of the instrument panel airbag lower and place caulking sponge on the airbag side.
- ② Cut right and left ribs at the back of the instrument panel airbag lower No. 1 cover
