**Technical Service
Information Bulletin**

**MIRROR MEMORY INACCURATE AFTER
REVERSE TILT**

'03 – '06 LX 470

ELECTRICAL
EL007-06

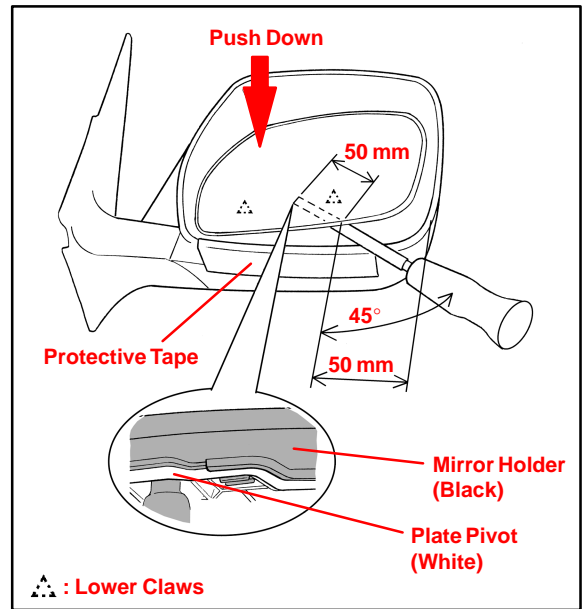
1. Disconnect the mirror.
 - A. Disconnect the negative (-) battery terminal.
 - B. To prevent damage, apply protective tape on the lower side of the mirror body.
 - C. Push the upper corner of the mirror to tilt out the lower corner.
 - D. Insert a flat blade screwdriver between the mirror holder (black) and plate pivot (white), and twist to disconnect the two (2) lower claws.

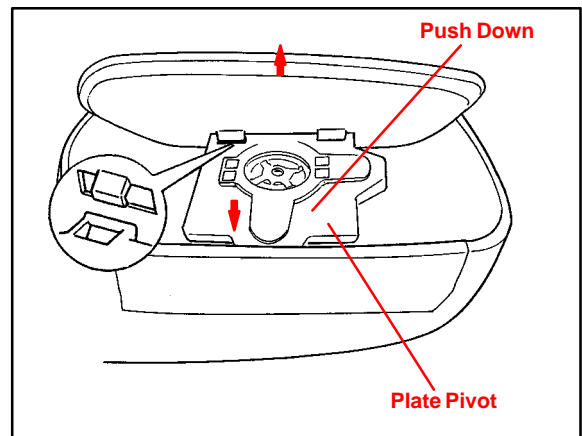
- E. Push the lower side of the plate pivot to tilt it down.
 - F. Pull up the mirror to disconnect the two (2) upper claws.

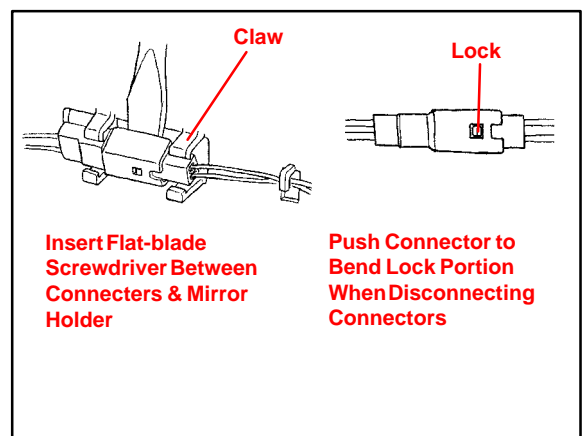
- G. **For heated mirrors:**
Disconnect the 4-pin connector from the mirror assembly.

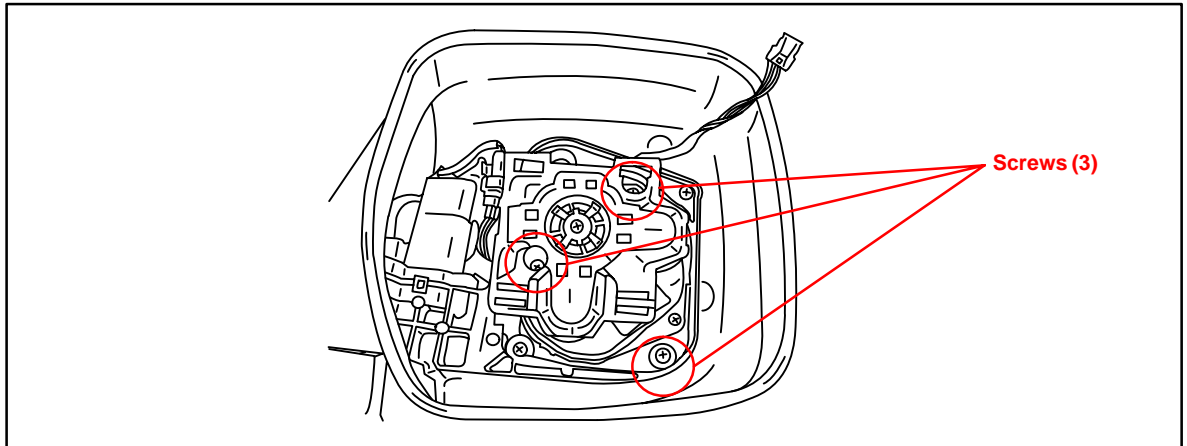
2. Remove the mirror actuator.
 - A. Remove the three (3) screws from the actuator.

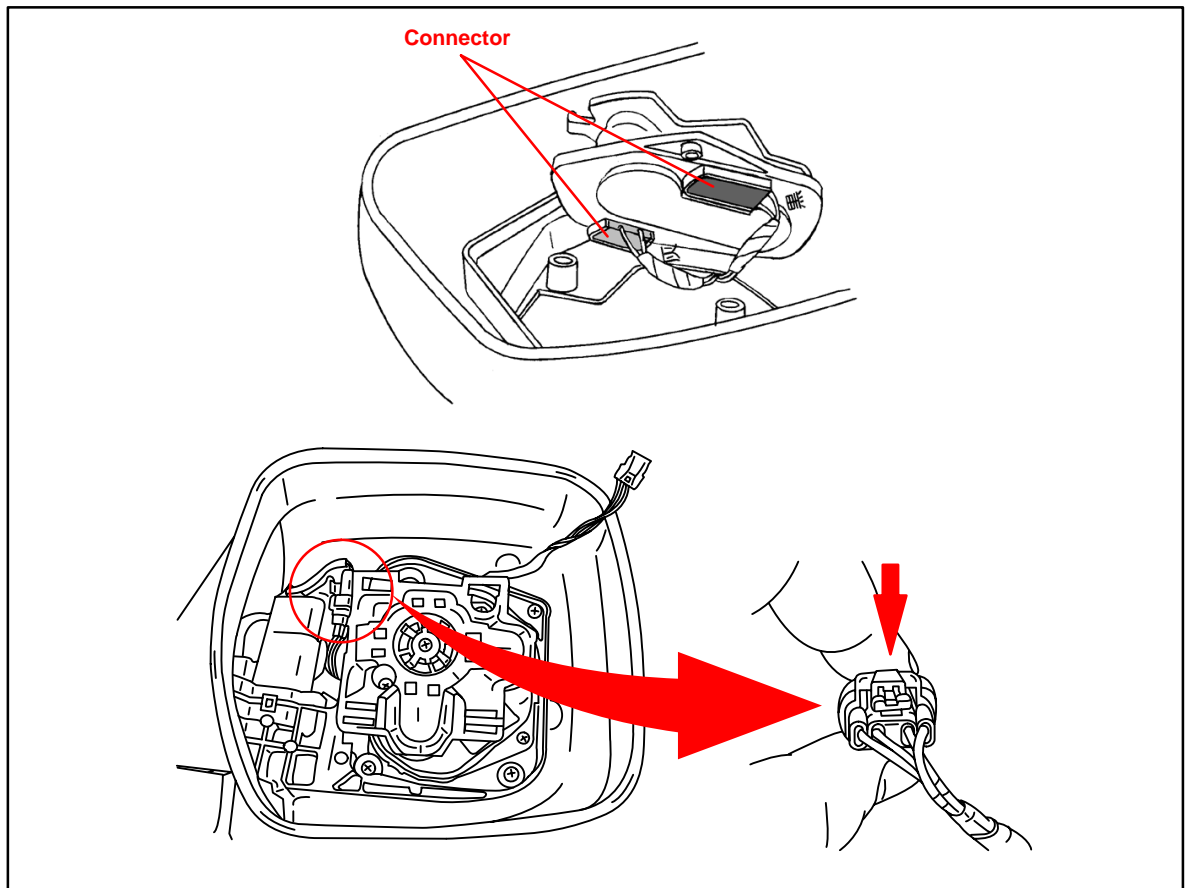
- B. Gently disconnect the three (3) connectors from the mirror actuator.

Disconnect the 5-pin connector by pushing down on the lock tab.

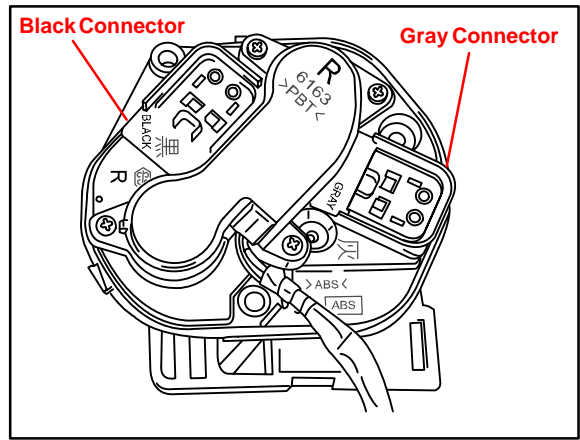
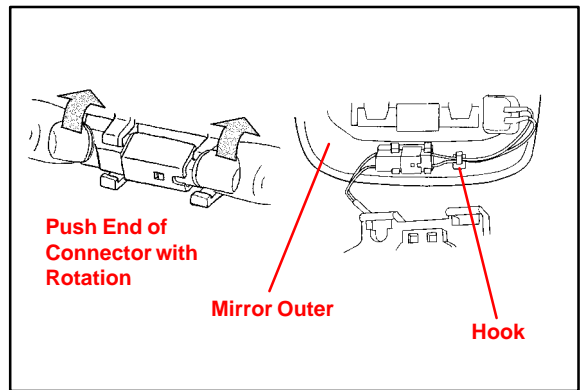
- B. **For heated mirrors:** Resecure the heater terminals.

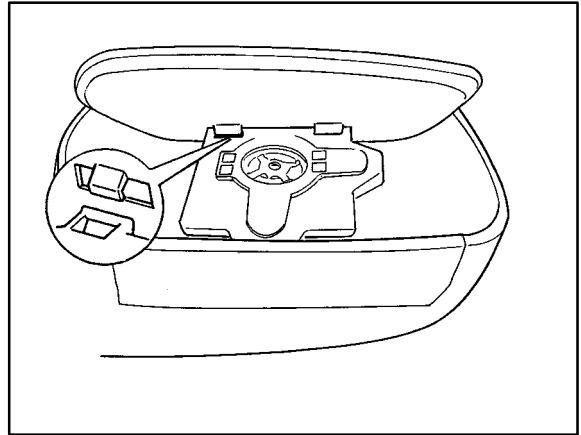
- C. Hook the upper claws of the mirror holder into the plate pivot.

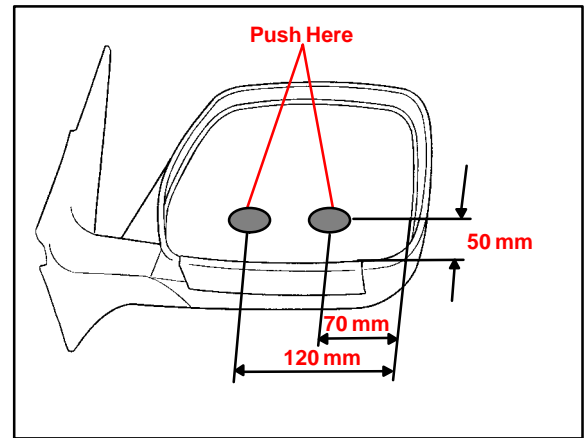
- D. Reconnect the mirror holder —
Apply pressure to the indicated
areas until you hear the holder
clips snap into place.

If pressure is applied in areas other
than the ones indicated, the mirror
glass may break.
