**Technical Service
Information Bulletin**

Title:
DASH RATTLE REPAIR

Models:
'04 – '05 RX 330

REVISÉD
NV007-04
NVH

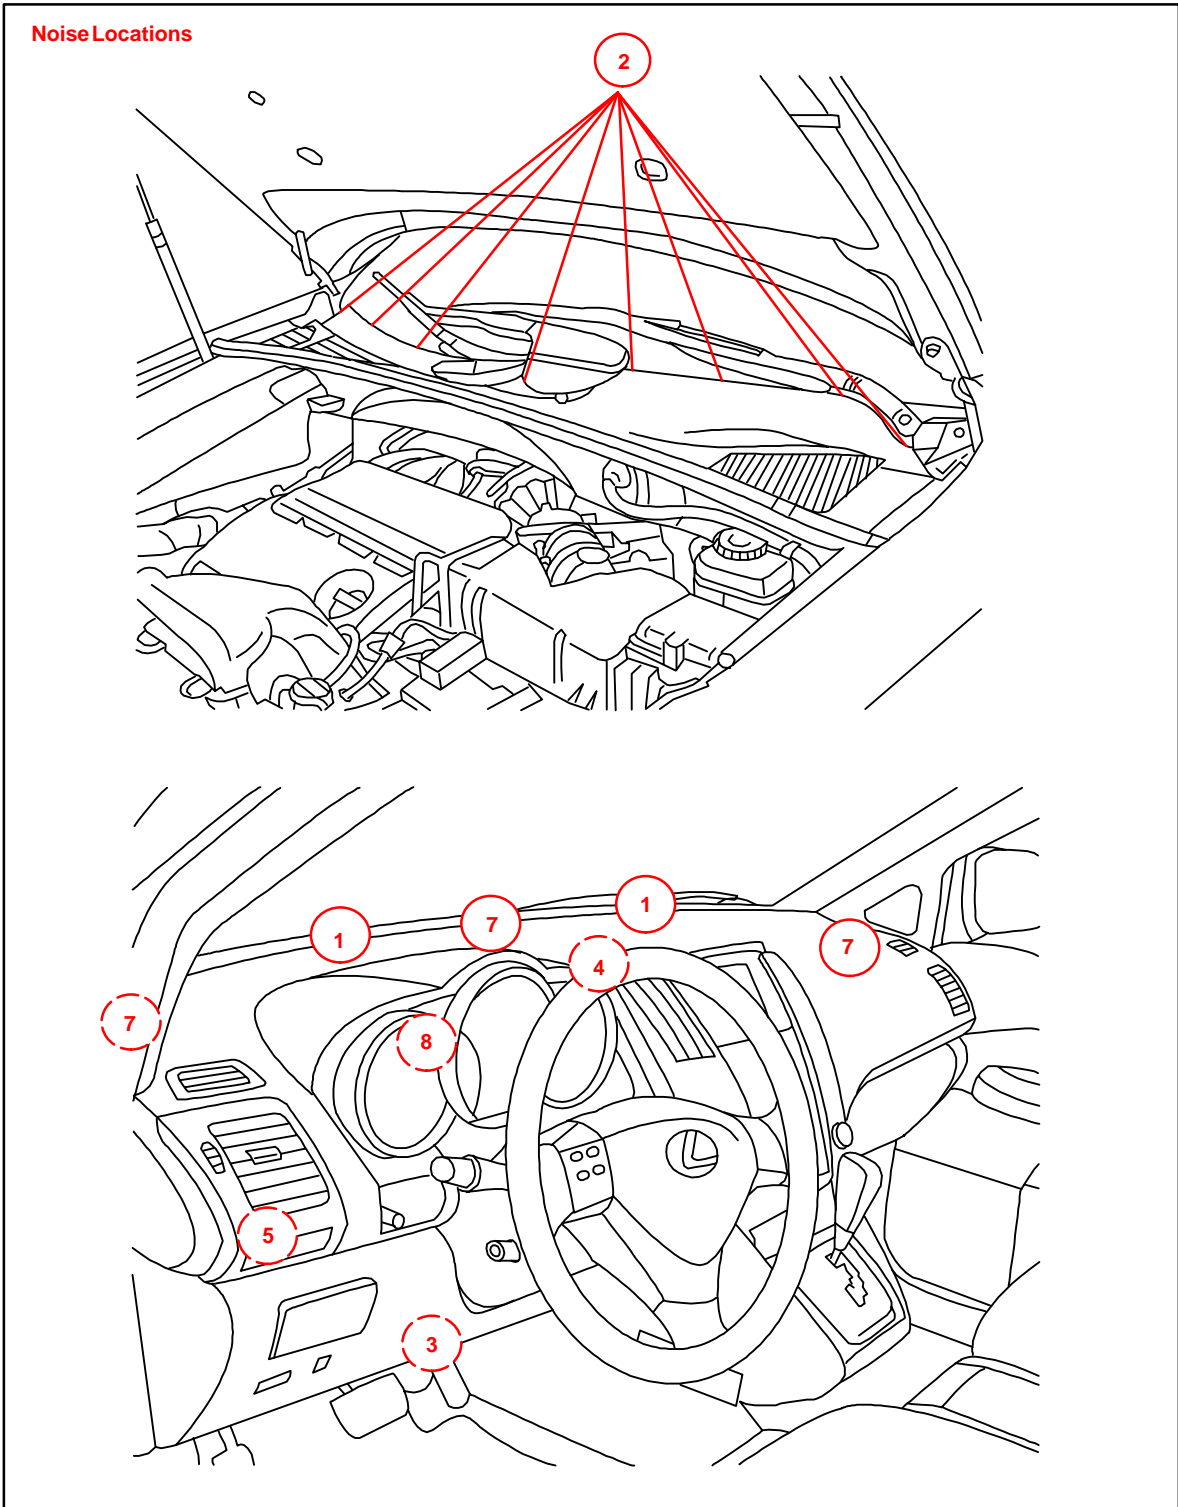
NOISE AREA LOCATION	REPAIR PROCEDURE
Front of Instrument Panel Center Area (Defroster Nozzle)	1
Cowl Louver Area	2
TRAC OFF Switch Area	3
Defroster Duct (Wire Harness Above Duct)	4
Driver's Side Cup Holder Area	5
Instrument Panel Front Area (Dash Removal)	6
Instrument Panel Front Area (Insertion Pins)/Bulkhead/HVAC Cover	7
Combination Meter Area (Wire Harness Behind)	8

NOTE:
 Repair procedures 1, 4, 6, and 7 require removal of the dash pad. For dash removal, follow the precautions and instructions to remove the dash pad sub-assembly as identified in the Technical information System (TIS), 2004 model year RX 330 Repair Manual: *Instrument Panel/Meter: Instrument Panel Safety Pad Sub-Assembly: Precaution and Replacement.*
